# BULKHEAD INSPECTION REPORT

**2596 Southeast 13<sup>TH</sup> Court  
City of Pompano Beach**

**June 2012**

## **BULKHEAD INSPECTION REPORT**

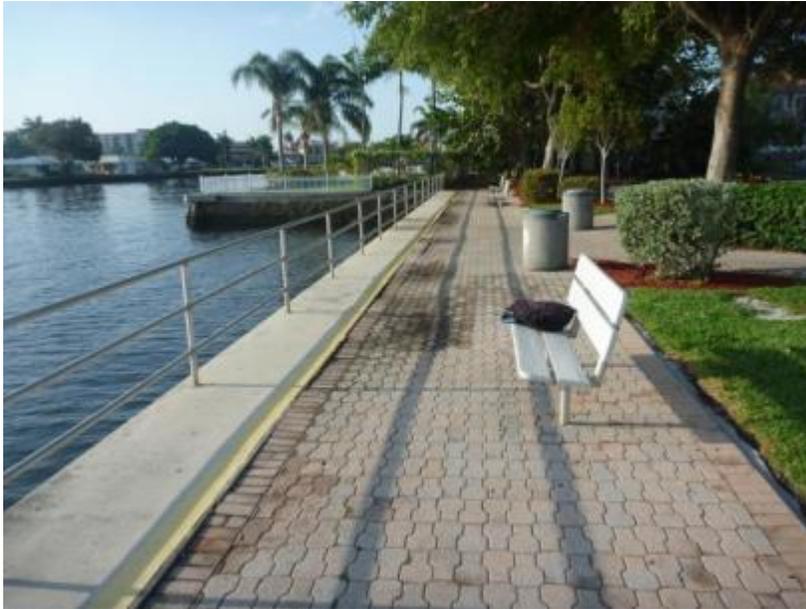
The bulkhead measures approximately 148 feet in length and parallels the ICWW in a general north – south direction. The exposed height (seaward berm to top of cap) of the bulkhead ranges from approximately 5'-6" at the south end to approximately 7'-0" at the northern terminus. The bulkhead abuts residential bulkheads on both the south and north sides of the park facility. (Plates A – D)

**Plate A**  
**View South**

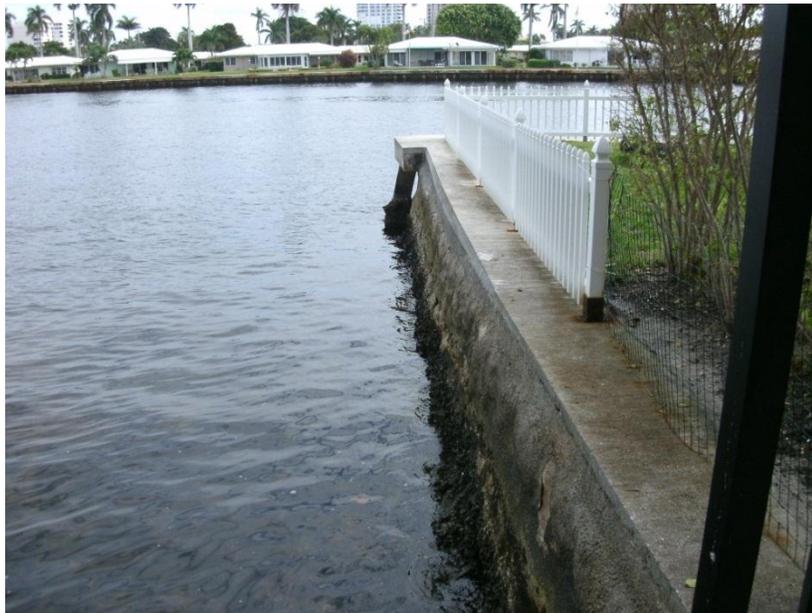
**Plate B**  
**Abutting South Bulkhead**

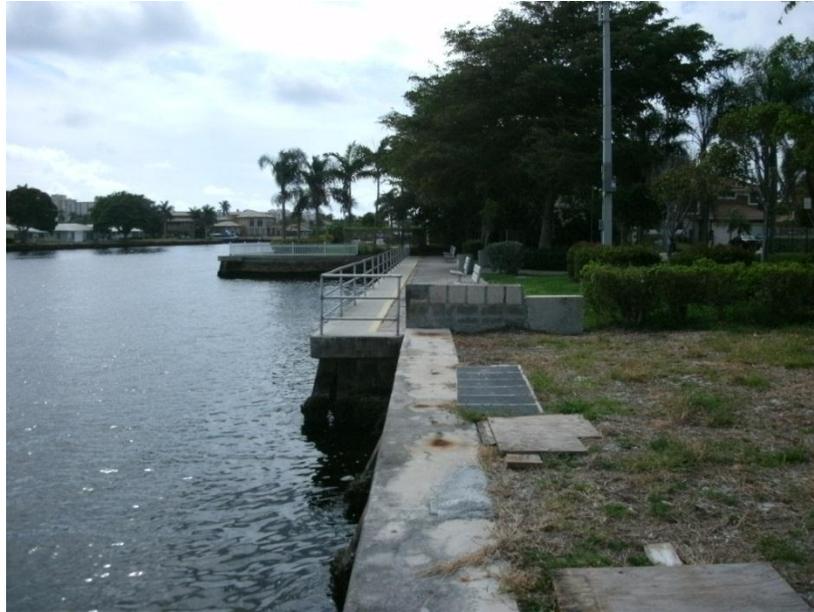
**Plate C**  
**Abutting North Bulkhead**

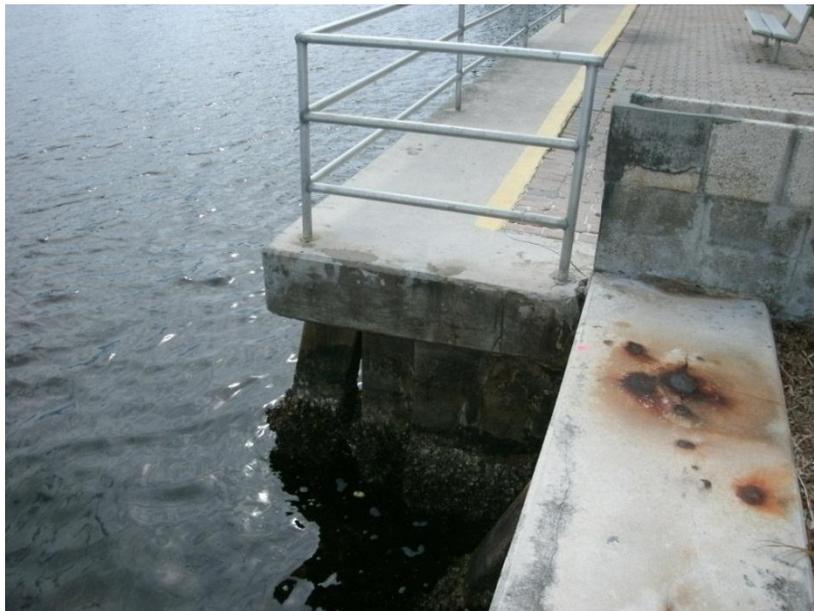
**Plate D**  
**North terminus of bulkhead**

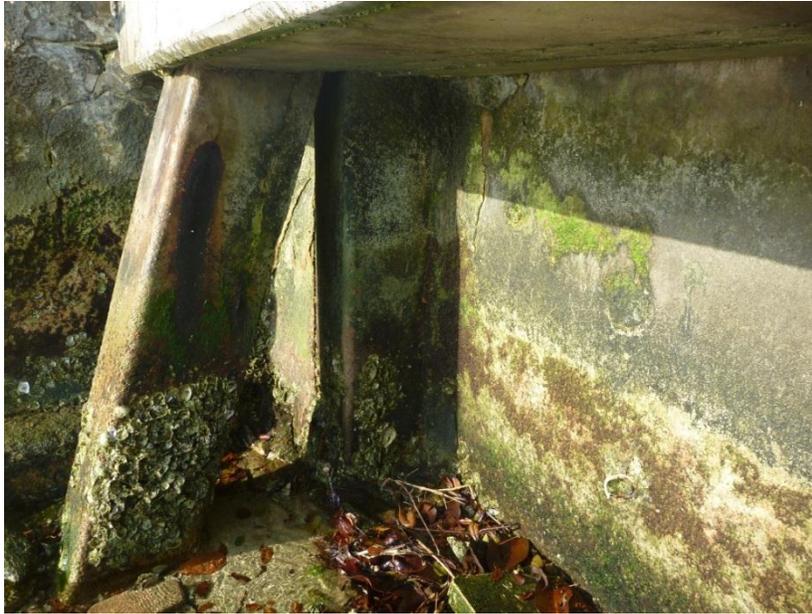
The bulkhead is comprised of vertical concrete panels approximately 10' in width supported laterally by 12" inch square prestressed concrete king and batter piles. ( Plate E) The bulkhead has an integral concrete cap, 3'-6" in width by 12" deep with top of cap elevation of 3.40' NAVD. The concrete panel thickness and depth of panel embedment, as well as the length and type of concrete king and batter piles (strength of concrete, size and number of strands) is unknown. Additionally, the construction characteristics of the concrete panels and cap are unknown. Along the bulkhead there is an aluminum railing, 3'-4" in height with post embedded and grouted into the upper face of the concrete cap. Landward along the entire length of the bulkhead there is a brick paver walkway, 9' in width that abuts the backside of the concrete cap. Beyond the paver walkway the site generally consists of grass and natural landscape extending to the asphalt cul-de-sac of Southeast 13<sup>th</sup> Court. Other park features include overhead lighting, park benches and trash receptacles. (Plate F)

**Plate E**  
**Typical concrete panel supported by king and batter pile**  
**(Pile Group No. One – See Plan)**

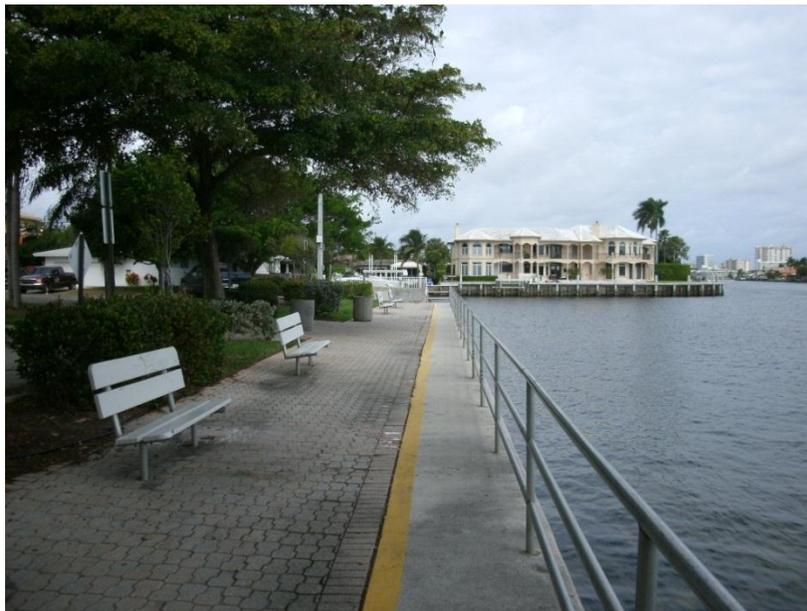
**Plate F**  
**View North – Upland Site Features**

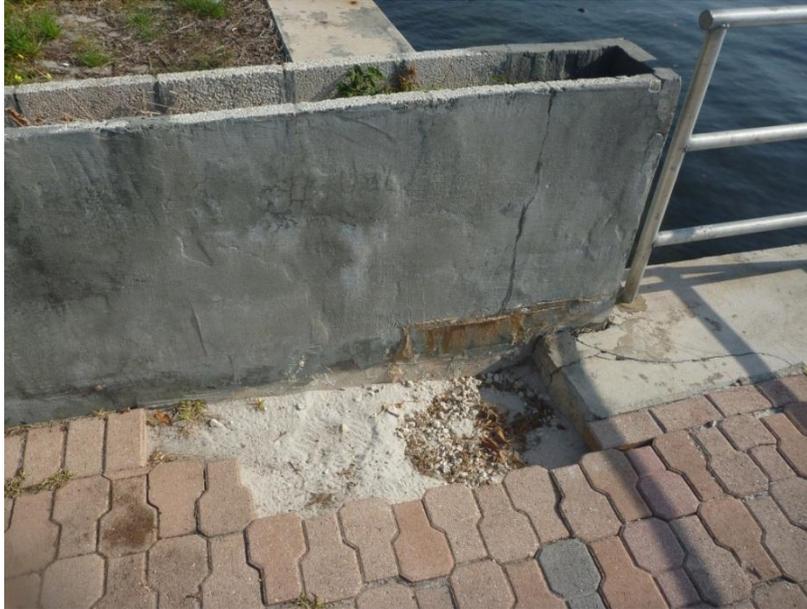
Based on topside visual observations, the bulkhead appeared to be structurally sound with no visual signs of major structural cracks in the concrete cap with the exception of the northerly return wall at the tie-in point to the adjacent residential concrete bulkhead structure. (Plate G) It is apparent the cracks could be a result of differential movement between the abutting bulkheads, impacts caused by the addition of the concrete wall / planter or aluminum railing, loss of backfill material at the point of adjoining bulkhead intersection and / or poor design / construction.

A predominate area of noticeable deterioration of the bulkhead was along the northerly return section at the abutment or tie-in point to the adjacent residential bulkhead to the north of the Park. This junction shows evidence of being repeatedly patched, with significant buildup of cement and mortar at the point of intersection. The existing patches were weak and easily displaced, and significant cracking was observed in the concrete cap. (Plates N and O) It is evident that the deterioration of the seal between the adjoining bulkheads had reached a point that backfill material was escaping from behind the wall into the waterway resulting in settlement of the paver block walkway at this location. This loss of backfill material may also be the cause of cracks in the small concrete block wall and landward edge of the concrete cap. Immediately adjacent to this area, a small section of paver blocks had been removed and what appeared to be new sand added to fill the voids resulting from the loss of material. (Plate G)

**Plate G**  
**Crack in Upper Face of Concrete Cap at North Return Wall**

Task Two: North abutment (tie-in) to adjacent bulkhead.

Step One: Chip and remove all broken and loose grout and concrete material along the joint between the two walls. Seal with hydraulic cement extending from the underside of the concrete cap to 12" below the berm line.

Step Two: Excavate backfill material from behind the wall at the point of intersection of the two adjoining walls. Care shall be taken not to undermine the foundation supporting the block wall / planter that extends westerly from the bulkhead. The objective is to expose the joint between the two walls as deep as possible in order to add a geotextile fabric material serving as a secondary measure of prohibiting seepage of backfill material into the waterway. Replace backfill material, adding additional as necessary and compact using a light weight vibratory compaction machine. A low volume / low pressure water jet system shall be used to wash sand into any voids that may exist in the area of repair. Reference plan for details.

Step Three: Sawcut, chip and remove section of damaged cap maintaining the aluminum railing post in position. Sawcut and remove concrete to a depth that exposes the steel reinforcing steel without damaging the steel. If the cracks in the cap extend beneath the steel rebar (assuming there is steel reinforcing in this section of cap), chip and remove concrete to the full limits of cracking. Add and / or replace damaged rebar as per the direction of the Engineer, then form and re-pour concrete using a minimum 4000 psi , 0.40

water/cement ratio concrete mix design. A proper bonding agent shall be used between existing and new concrete. Finish to match existing and undamaged section of cap as reasonably possible.

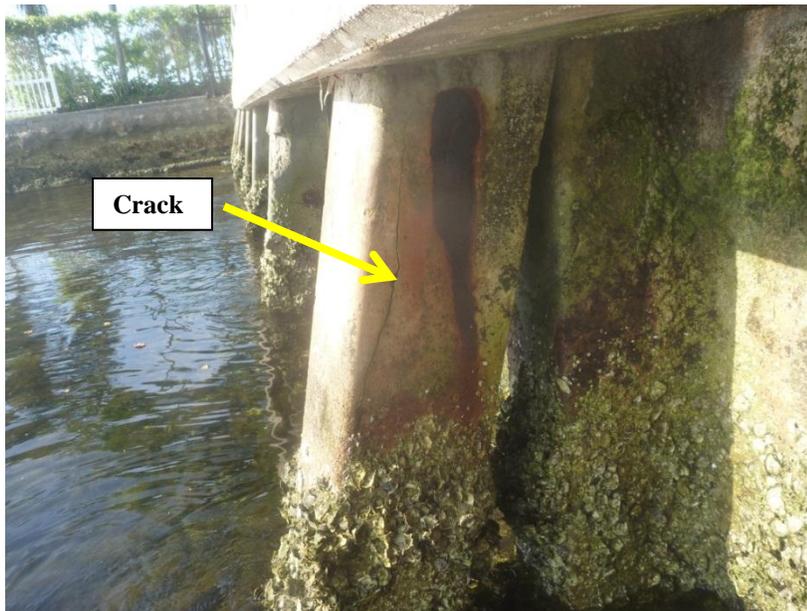
The in-water inspection revealed several cracks and spalls in several of the king and batter piles, which are referenced on the plans accompanying this report. (Plates H – K). Cracks were not observed to be at a level of severity to indicate structural failure, however should be addressed and monitored in accordance with the recommendations included in this report. It is noted that major cracks are considered, herein as a crack being greater than 1/8-inch in width.

**Plate H**  
**Crack in North Face of Concrete Batter Pile**  
**(Batter Pile Number 7 – See Plan)**

Task Four: Damaged King and Batter Piles

Step One: Chip and remove all broken and loose grout material used to repair piles as part of previous maintenance work. Re-grout area to match undamaged section of pile. Use forms as necessary to ensure uniformity of patch.

Step Two: Sawcut as practical, clean and epoxy inject all cracks exceeding 1/16" in width. At a minimum this will include three batter piles and one king pile as identified on the plan.

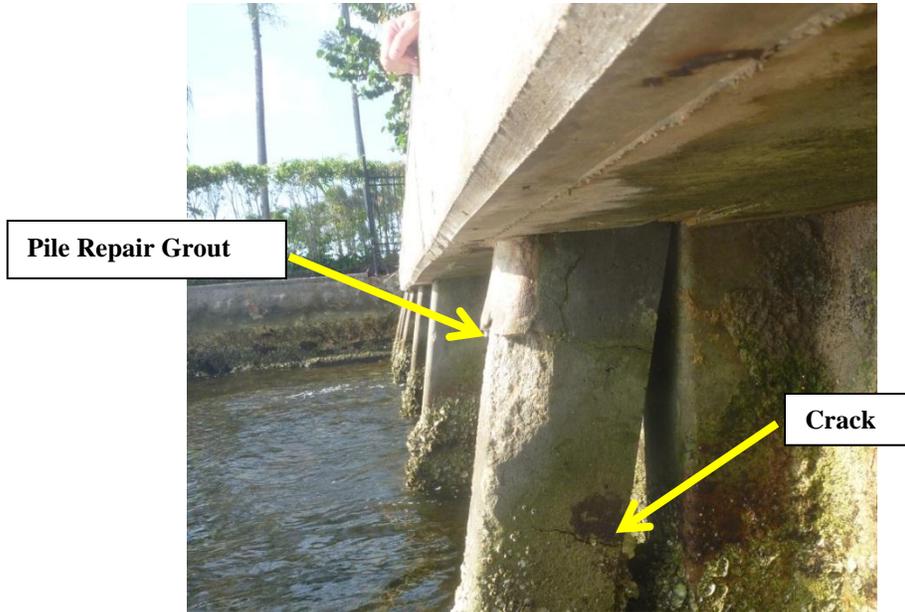
Cracks and missing grout material were observed in areas of previous repair work along the edges and faces of batter piles and along the vertical joints between king piles and concrete bulkhead panels. (Plates I, L and M) It is evident that grout material was used to repair damaged piles, which was probably caused by the pile driving operations during the construction of the bulkhead. For piles driven using a drop hammer, this damage is typically isolated to the upper end of the pile at the immediate point of impact. Any chips or damage to the top edges of the pile will generally be confined and hidden within the cast-in-place concrete cap or cut off in cases where the pile is not driven to grade. If the damage extends below the bottom edge of the cap, a common practice is to repair the pile using a concrete grout or hydraulic cement material. This repair work was evidenced at several of the batter piles and in certain cases the grout material had cracked or dislodged from the pile exposing the damaged portion of pile. There was no visual evidence, however that the deterioration of the repair grout material jeopardized the structural adequacy of the pile. Overall, the extent of cracking and missing grout material was minimal.

**Plate I**  
**Crack in North Face of Batter Pile along Back Edge and**  
**Damage / Missing Grout at Upper Edge**  
**(Batter Pile No. 6 – See Plan)**

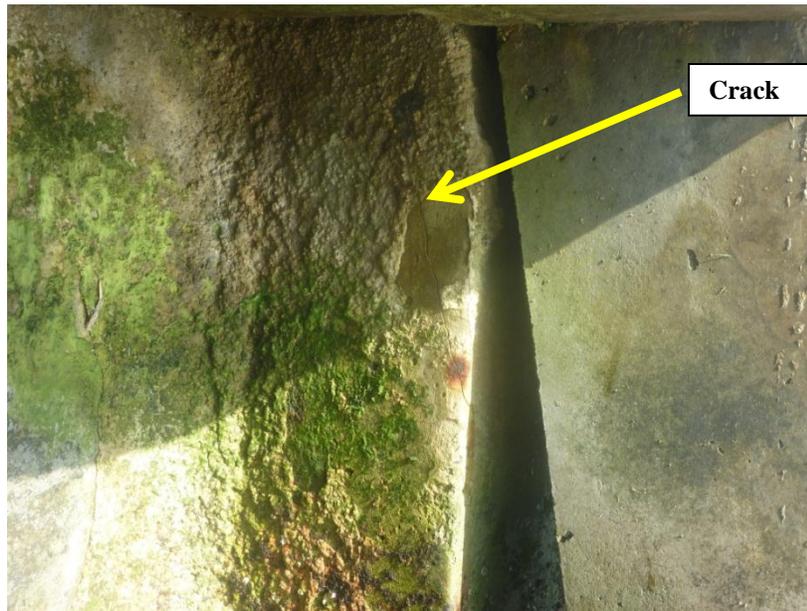
**Plate J**  
**Minor Crack in King Pile**  
**(King Pile No. 4 – See Plan)**

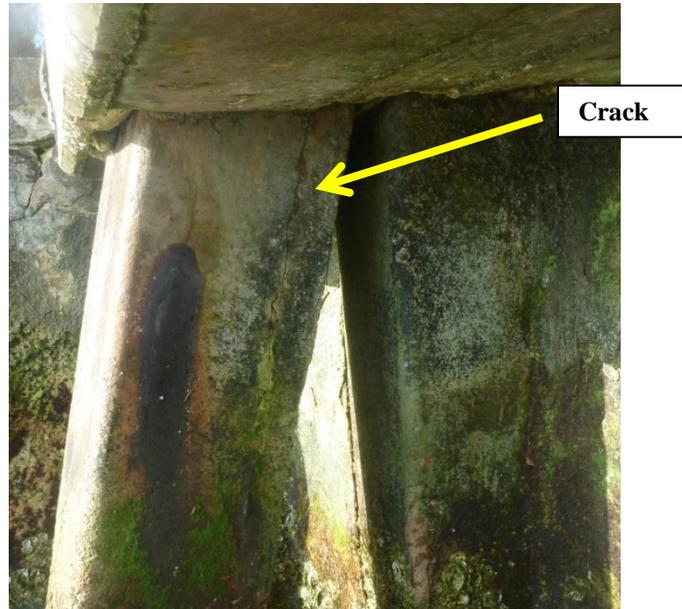
**Plate K**  
**Crack in North Face of Batter Piles along Upper Back Edge**  
**(Batter Pile No. 1 – See Plan)**

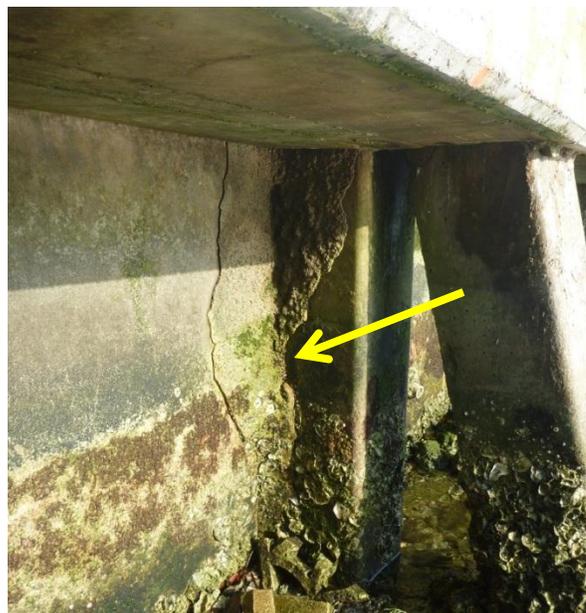
**Plate L**  
**Missing Grout Material - Typical**

Task One: Check, clean, repair and re-seal all joints between king piles and concrete panels using a hydraulic cement material, as necessary. Total number of king piles to check and re-seal is eighteen (18). Chip and remove all existing loose and damaged grout material prior to re-sealing. Sealing shall extend from underside of concrete cap to 12" below the berm line.

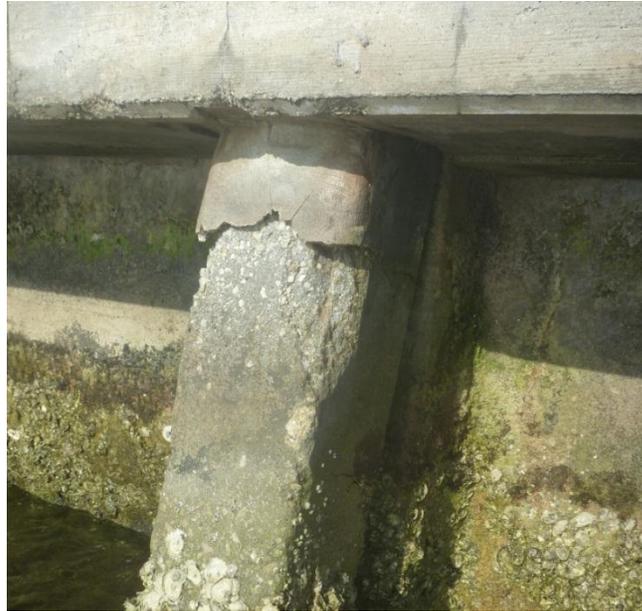
**Plate M**  
**Missing Grout Material at Previously Repaired**  
**Batter Pile – (Batter Pile No. 6 – See Plan)**

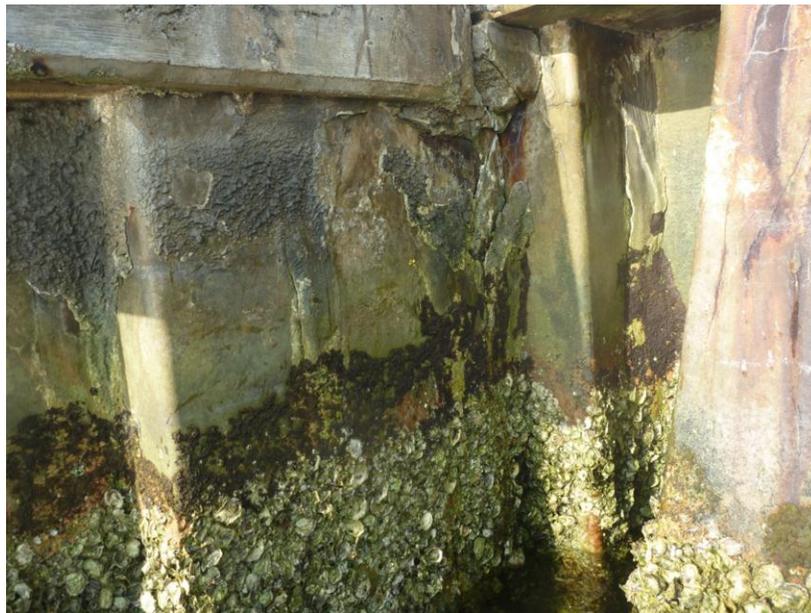
**Plate N**  
**Failing Joint at Interface with North Residential Bulkhead**

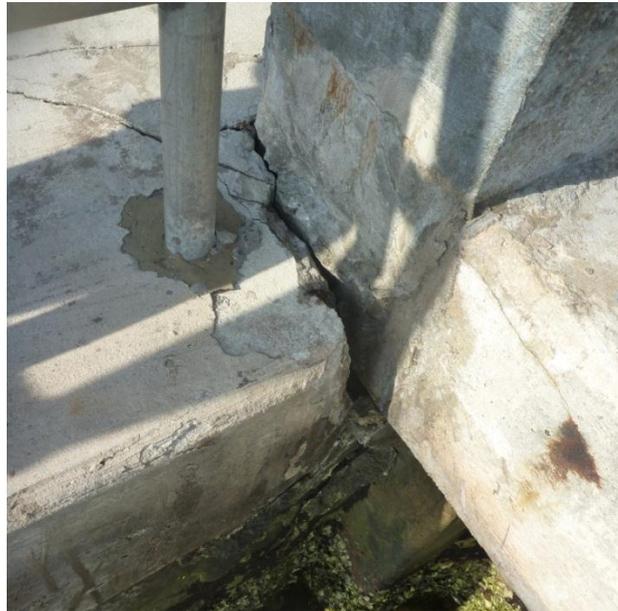
**Plate O**  
**Significant Cracks at Interface with North Abutting Bulkhead**

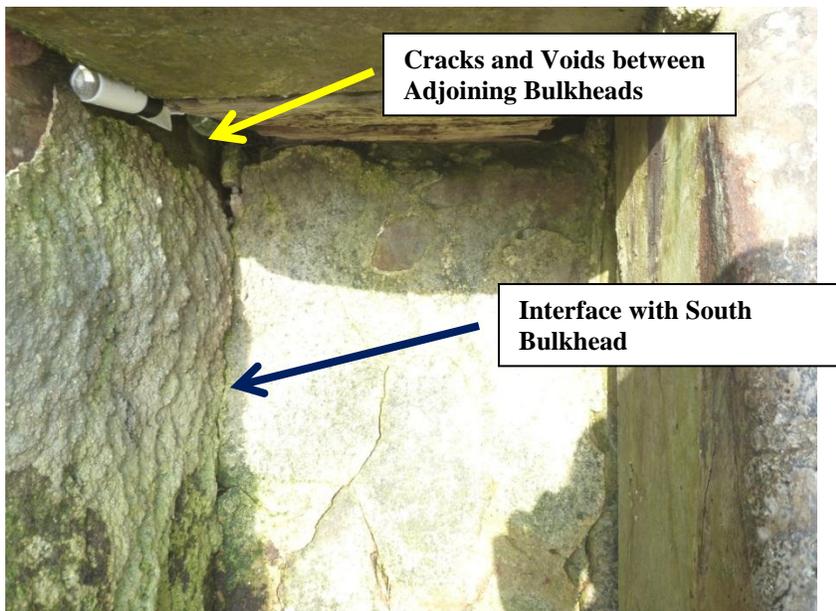
In-water inspection of the south tie-in to the adjacent bulkhead revealed no evidence of failure or major deterioration although it did not appear that this joint had been sealed along the seaward face allowing a small gap or void between the adjoining walls. (Plate P) There was no evidence that any material had escaped through the void indicating that the joint in the walls may have been sealed from the backside or some other means of prohibiting sand loss had been used such as the installation of a geotextile fabric material.

**Plate P**  
**Intersection with South Abutting Residential Bulkhead**

Task Three: South abutment (tie-in) to adjacent bulkhead.

Chip and remove all broken and loose grout, concrete material and debris along the joint between the two walls including the underside of the cap. Seal all joints and gaps with hydraulic cement extending from the underside of the concrete cap to 12" below the berm line.
