**FLORIDA DEPARTMENT OF TRANSPORTATION
BRIDGE MANAGEMENT SYSTEM
Inspection/CID/Bridge Profile Report**

BRIDGE ID: 868108
DISTRICT: 04 Fort Lauderdale

PAGE: 1 OF 63
INSPECTION DATE: 3/12/2013 TRQS

STRUCTURE NAME: Not Recorded
YEAR BUILT: 1959
SECTION NO.: 86 000 181
MP: 0.142
ROUTE: 00000
FACILITY CARRIED: MCNAB RD(SE 15 ST)
FEATURE INTERSECTED: CYPRESS CK C-14 CANAL

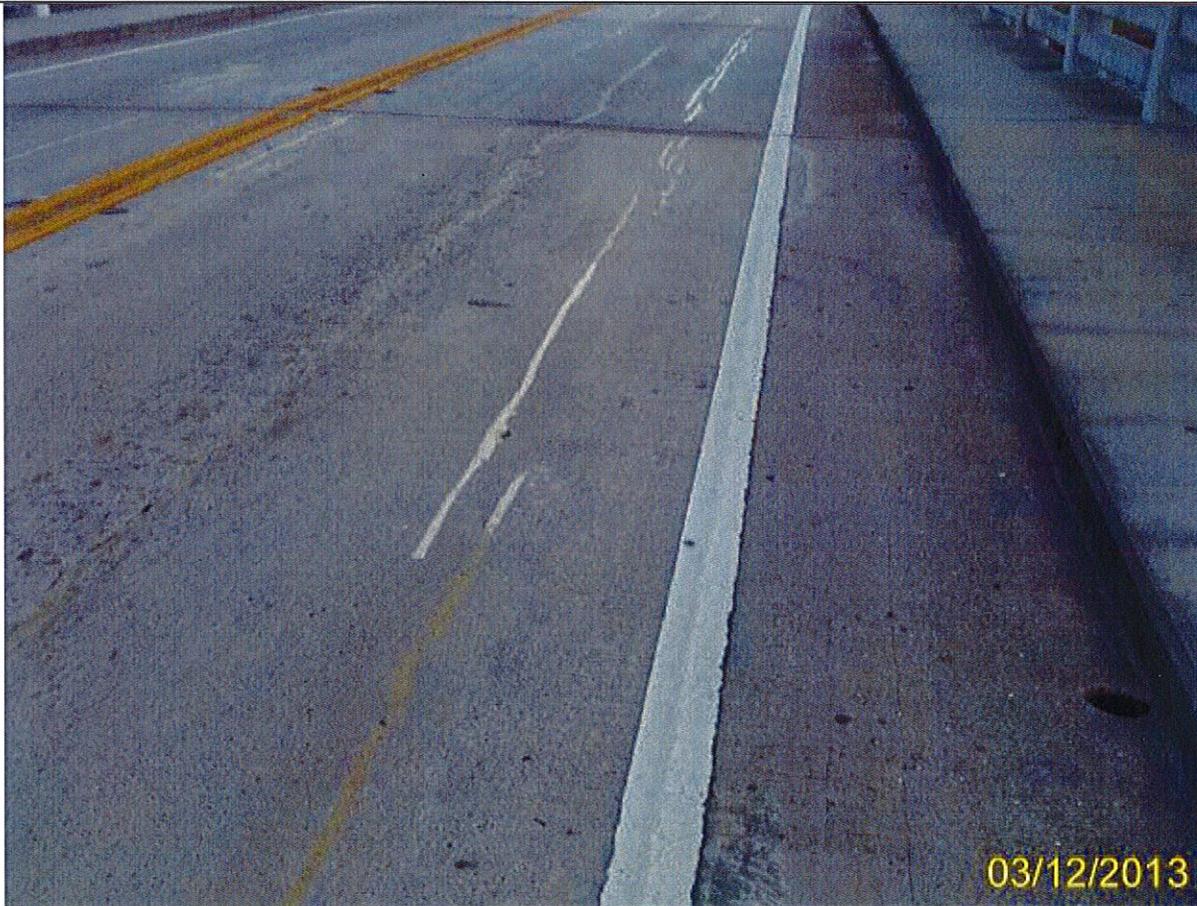
Photo 1 - Element 99 PS Conc Slab

Typical previously sealed longitudinal cracks in deck top (Spans 1, 2 and 3 shown)

REPAIR RECOMMENDATION:
None

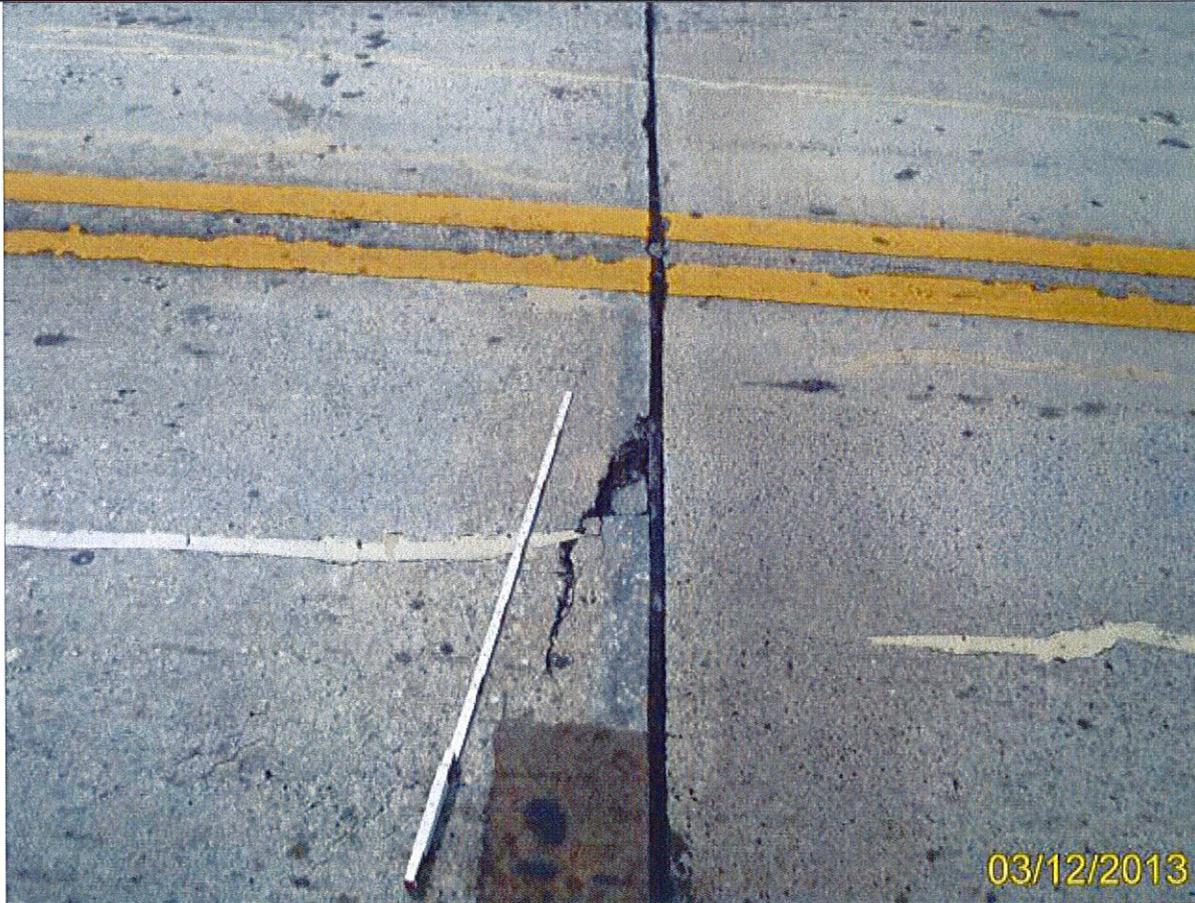
Photo 2 - Element 99 PS Conc Slab

Spall/delamination with exposed rebar in the westbound lane of Span 5 deck top at Bent 5

Repair all spalls/delaminations in the deck top of Spans 1 and 5. 20MH

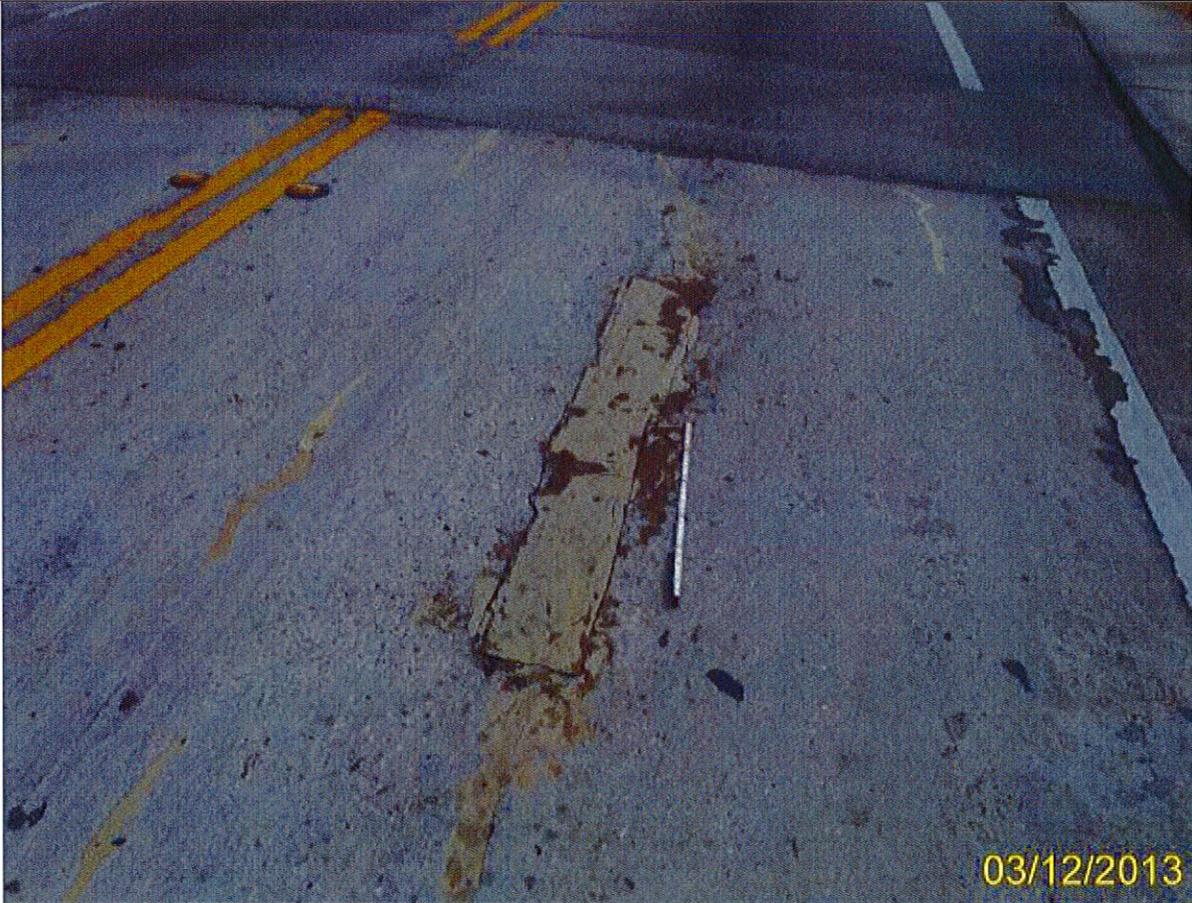
Photo 3 - Element 99 PS Conc Slab

Delaminated repair with associated cracking in the eastbound lane of Span 5, 6ft. from Abutment 6

REPAIR RECOMMENDATION:
Refer to photo 2.

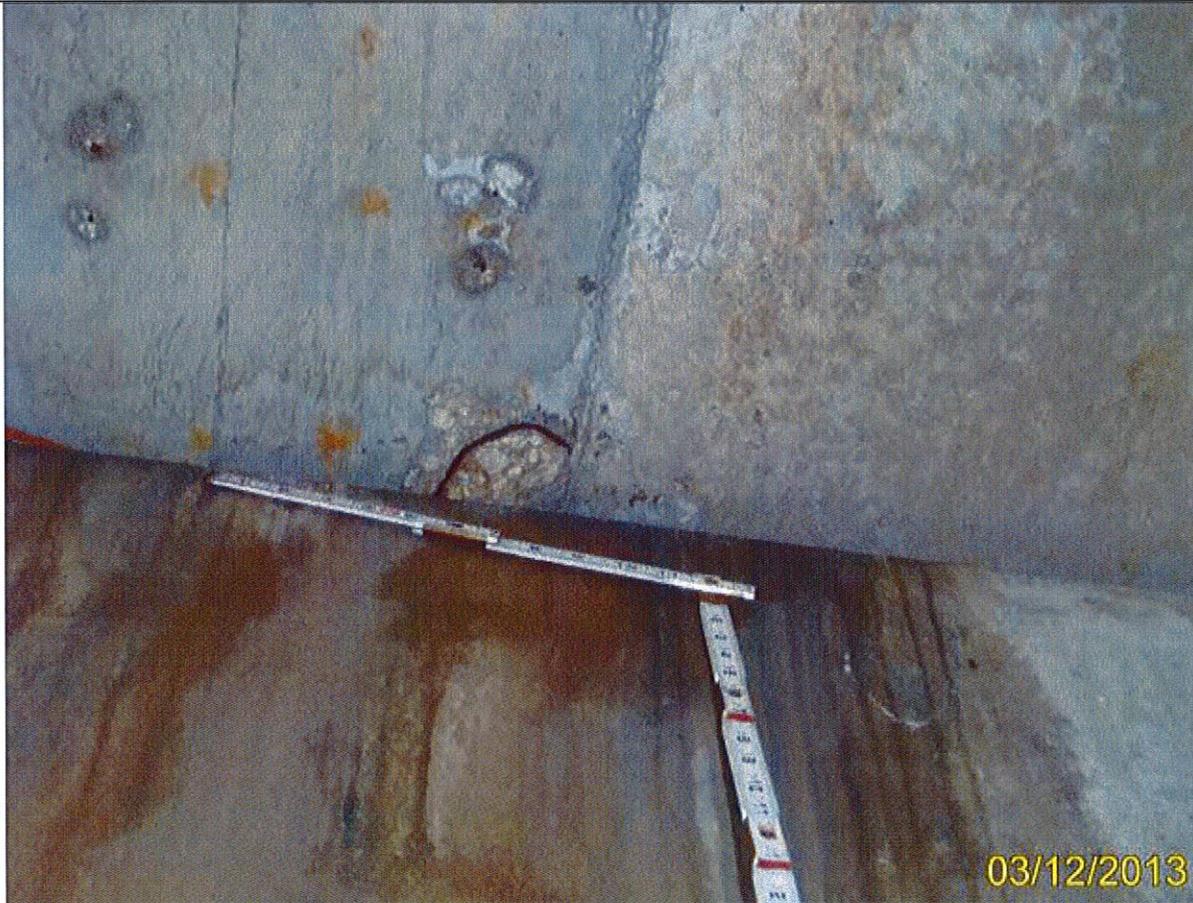
Photo 4 - Element 99 PS Conc Slab

The keyway has a 3in. x 3in. x 1/4in. spall with exposed tie wire adjacent to Slab Unit 1-14 at Abutment 1 - NO CHANGE. Refer to photo 4.

Spall with exposed tie wire in keyway adjacent to Slab Unit 1-14 at Abutment 1

Repair the spall with exposed tie wire in keyway adjacent to Slab Unit 1-14 at Abutment 1. 4MH

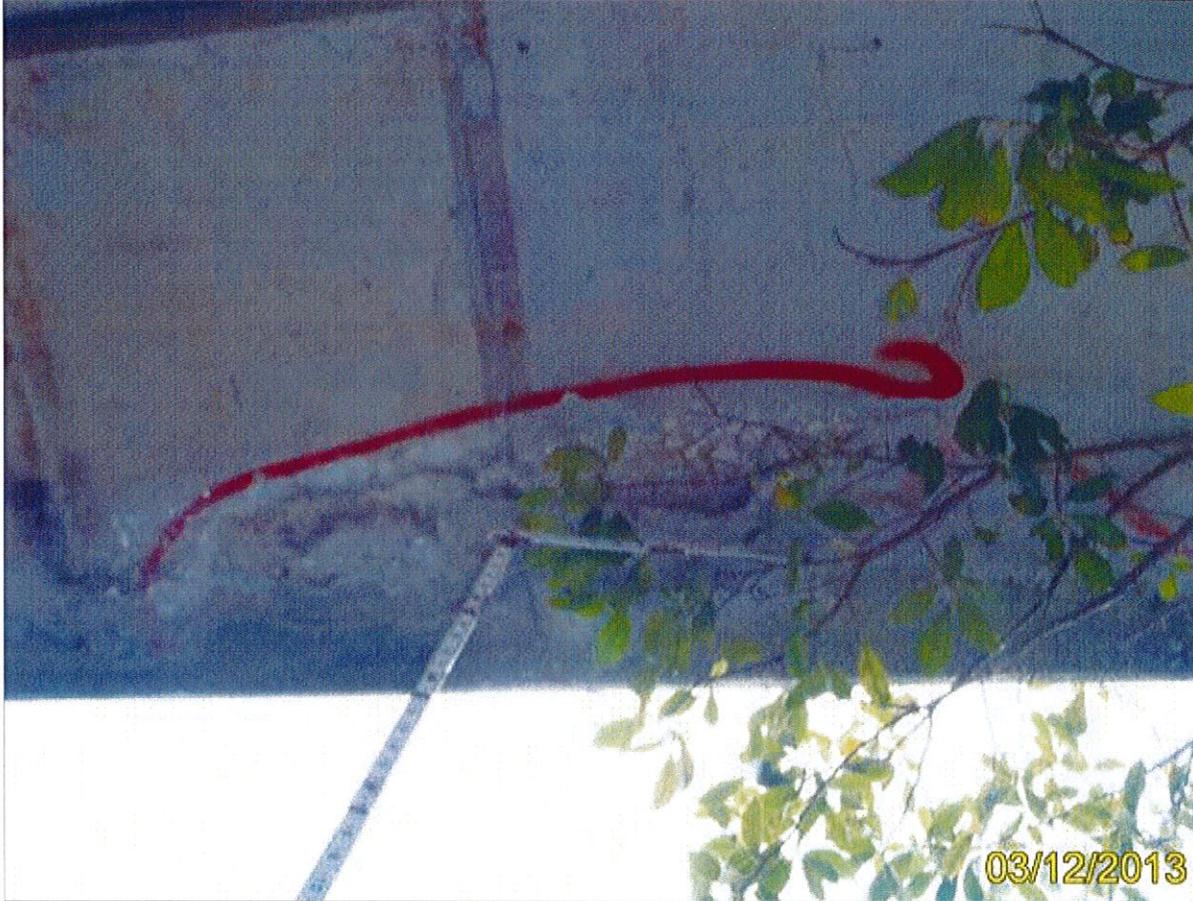
Photo 5 - Element 99 PS Conc Slab

The bottom north edge of Slab Unit 4-1 has a 3ft. x 1ft. x 2in. spalled/delaminated area, 3ft. from Bent 5 - NO CHANGE. Refer to photo 5.

Spall/delamination in bottom north edge of Slab Unit 4-1, 3ft. from Bent 5

Repair the spall/delaminations in the underside of Slab Units 4-1 and 5-16. 20MH

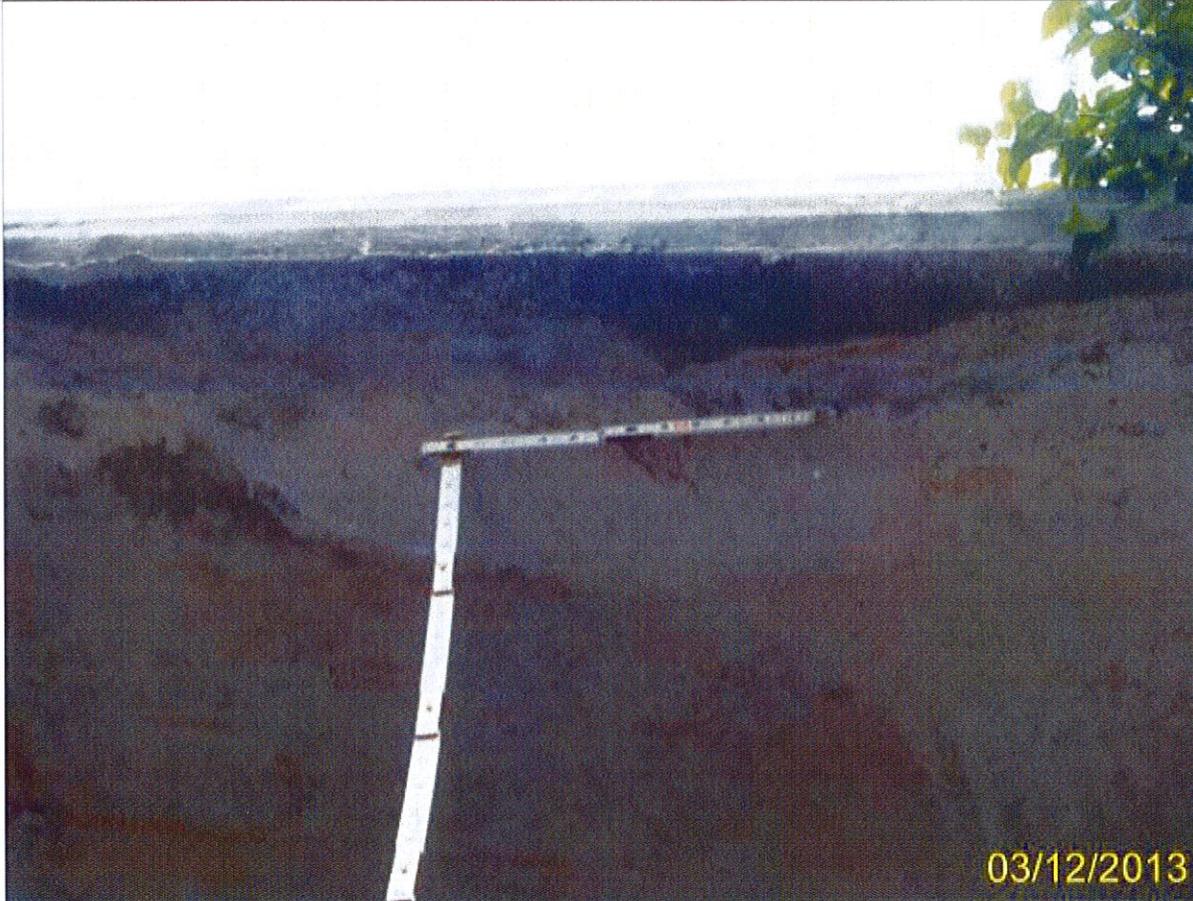
Photo 6 - Element 99 PS Conc Slab

Delamination in bottom south edge of Slab Unit 5-16, 1ft. west of Abutment 6

REPAIR RECOMMENDATION:
Refer to photo 5.

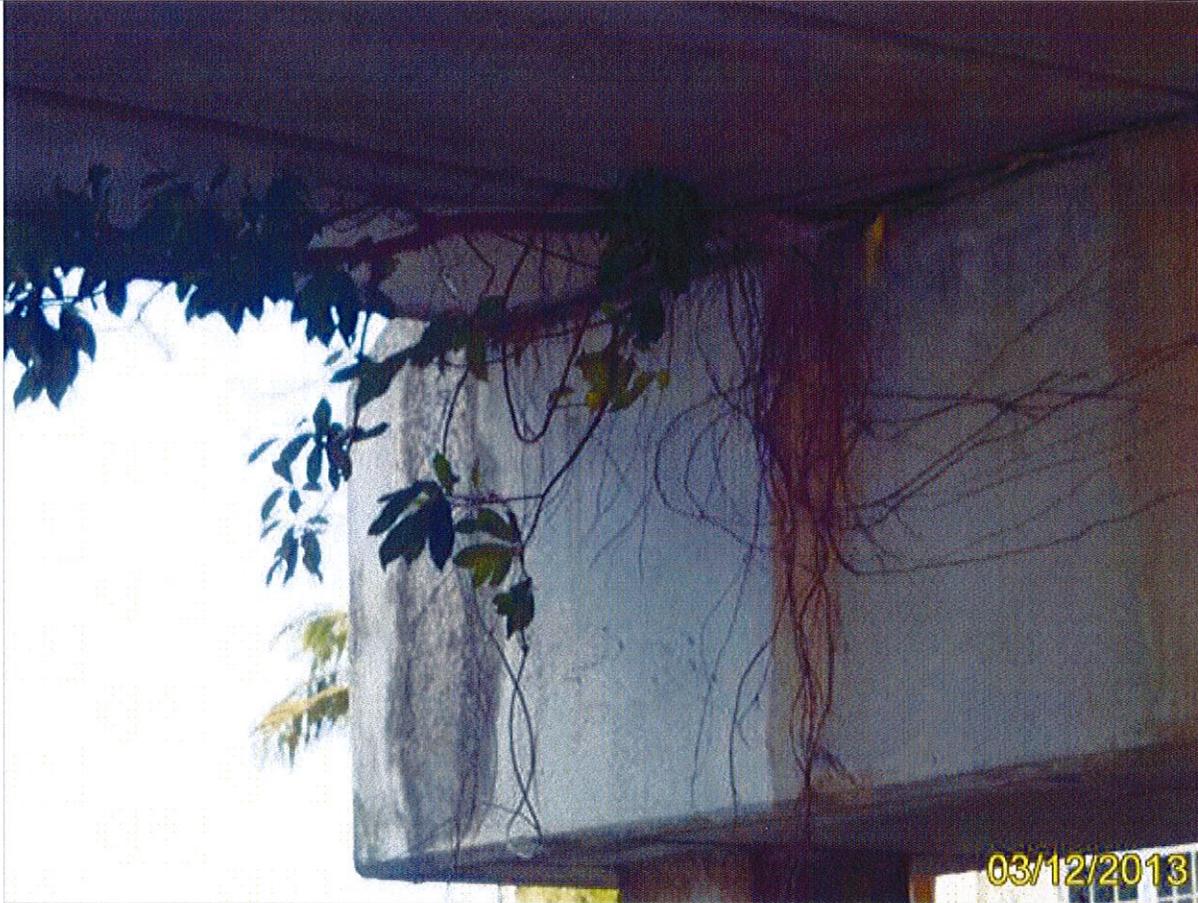
Photo 7 - Element 99 PS Conc Slab

Typical tree growing between slab units and cap (Slab Unit 4-2 at Bent 5 shown)

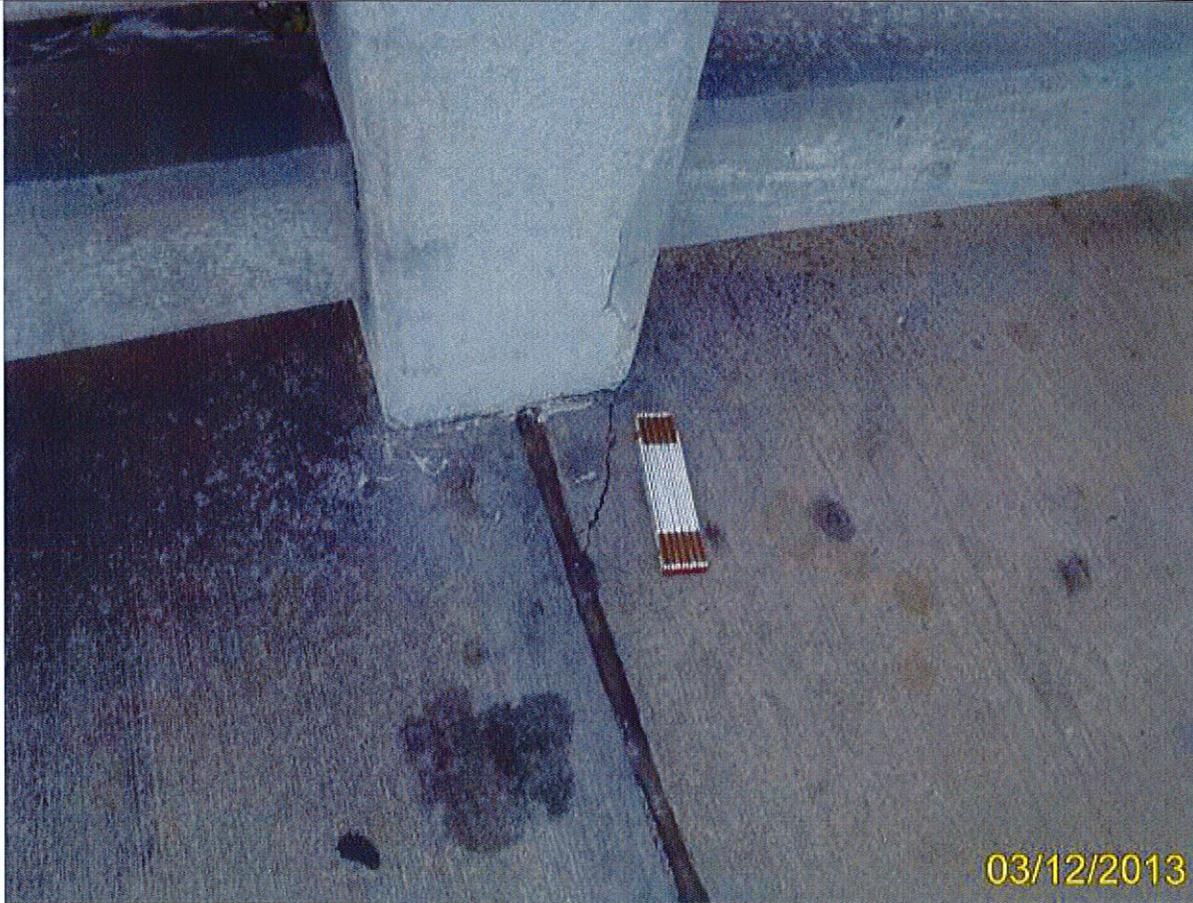
Photo 8 - Element 99 PS Conc Slab

Typical delaminated area in the right sidewalk (delamination at bridge rail Posts 2-4 shown)

Repair the two delaminated areas in the right sidewalk at bridge rail Posts 2-4 and 4-1. 4MH

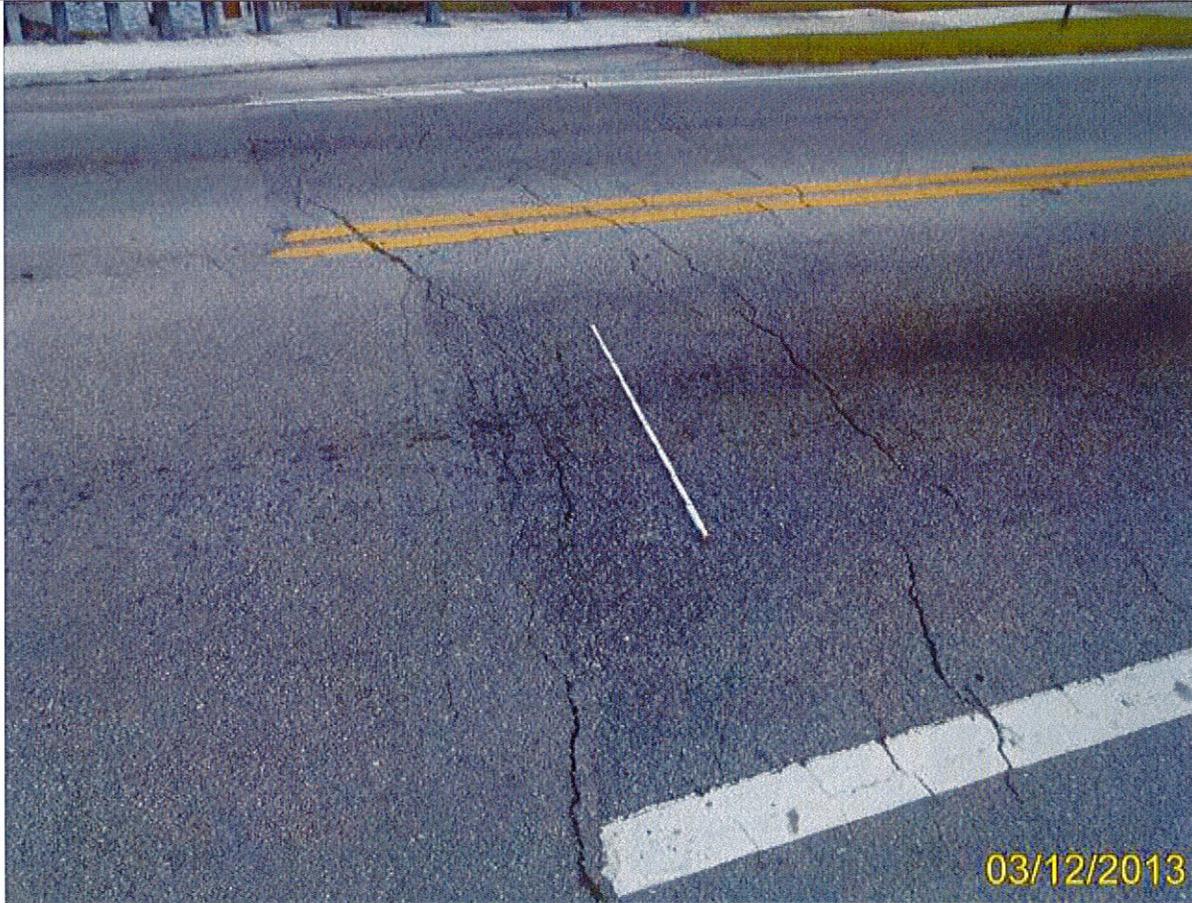
Photo 9 - Element 99 PS Conc Slab

The asphalt surfacing over the approach roadways and deck transitions has multiple settlement-related cracks up to roadway width x 1/4in. wide and depressions up to 10ft. wide x 1in. deep causing vehicles to bounce - NO CHANGE. Refer to photo 9.

Typical cracks and settlement in the asphalt surface over the approach roadway (east approach roadway shown)

Repair the cracks and settlement in the asphalt surfacing over both approach roadways and deck transitions. 24MH

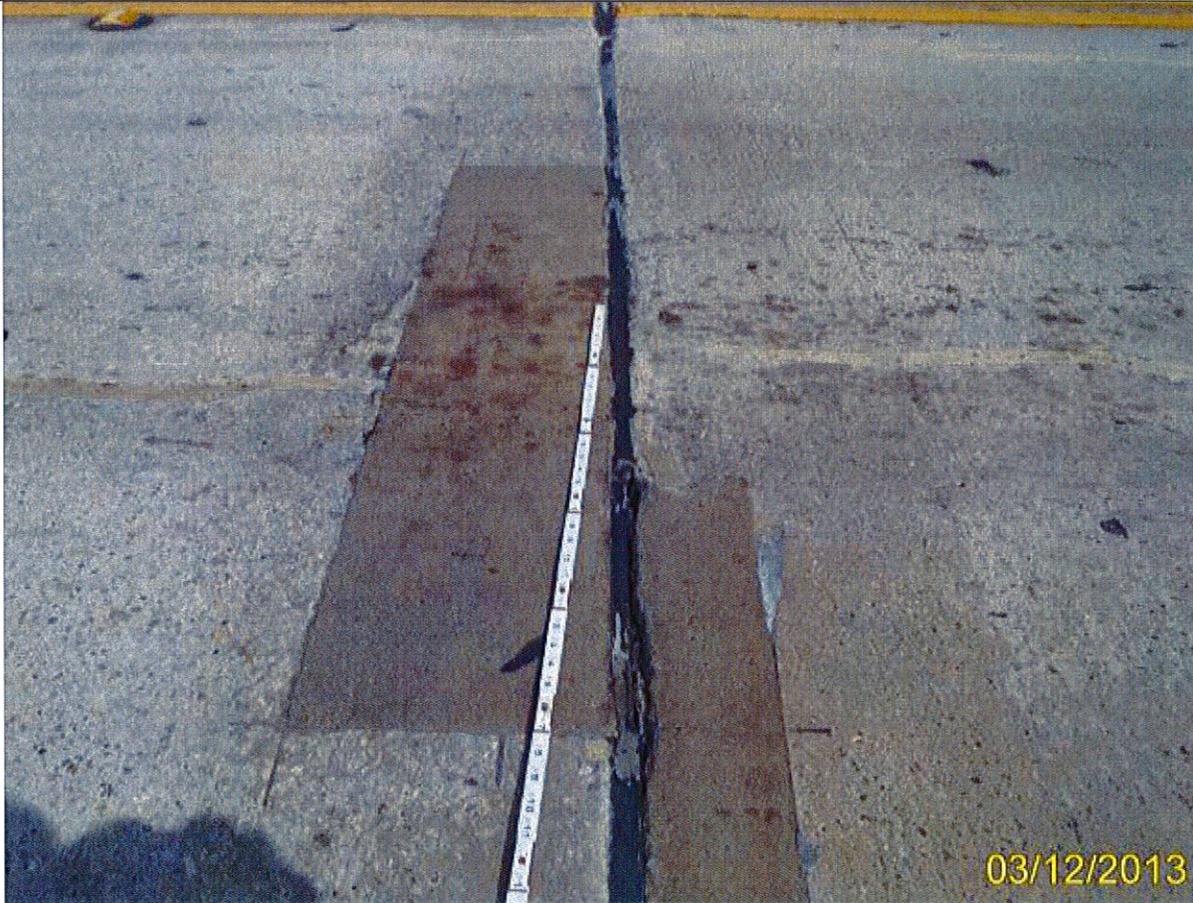
Photo 10 - Element 301 Pourable Joint Seal

Bent 2 joint has a 1.5ft. long area of deteriorated sealant in eastbound lane, adjacent to epoxy patches in the deck top – NO CHANGE. Refer to photo 10.

Deteriorated expansion joint sealant in eastbound lane of Bent 2 joint

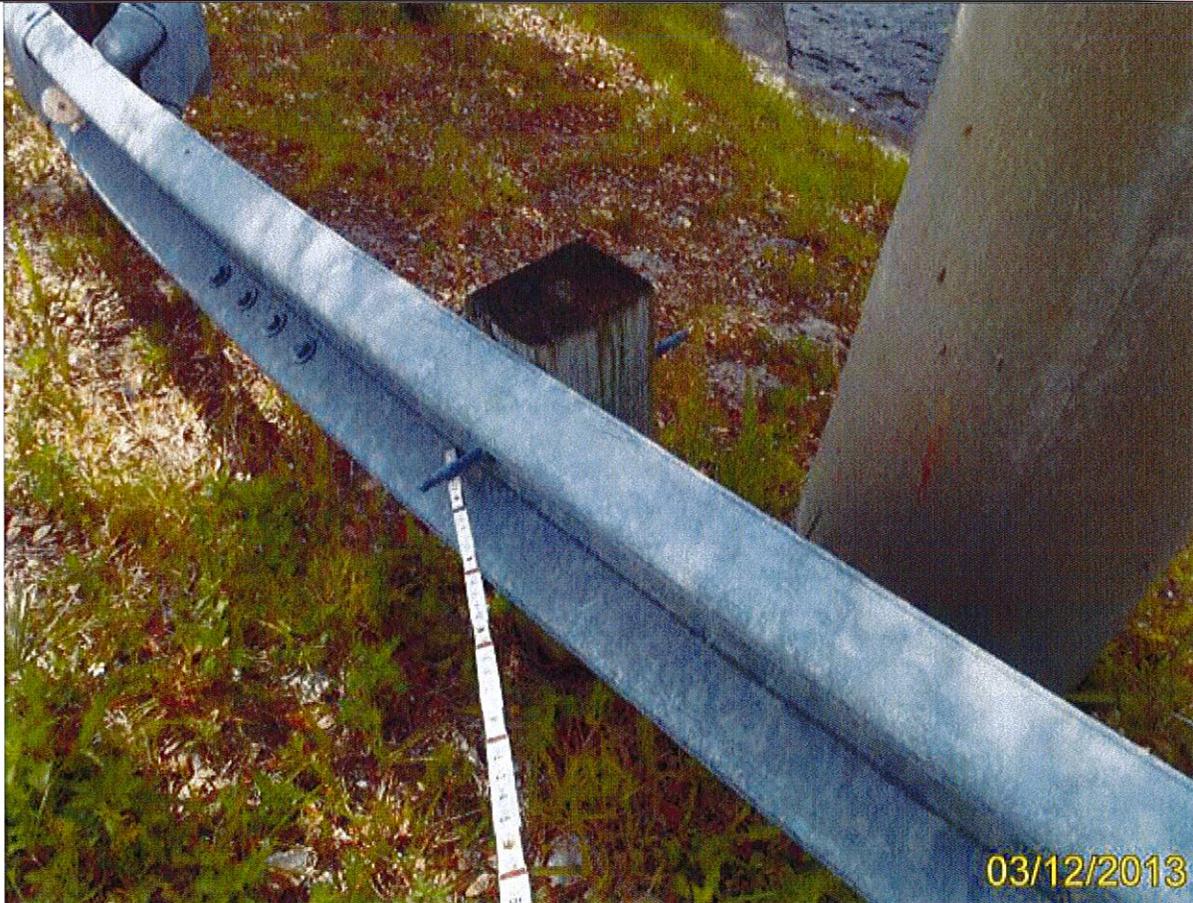
Photo 11 – Element 333 Other Bridge Railing

Threaded rod protruding at second post from southeast end terminal

Replace threaded rod with carriage bolt at second post west of the southeast guardrail end terminal. 4MH

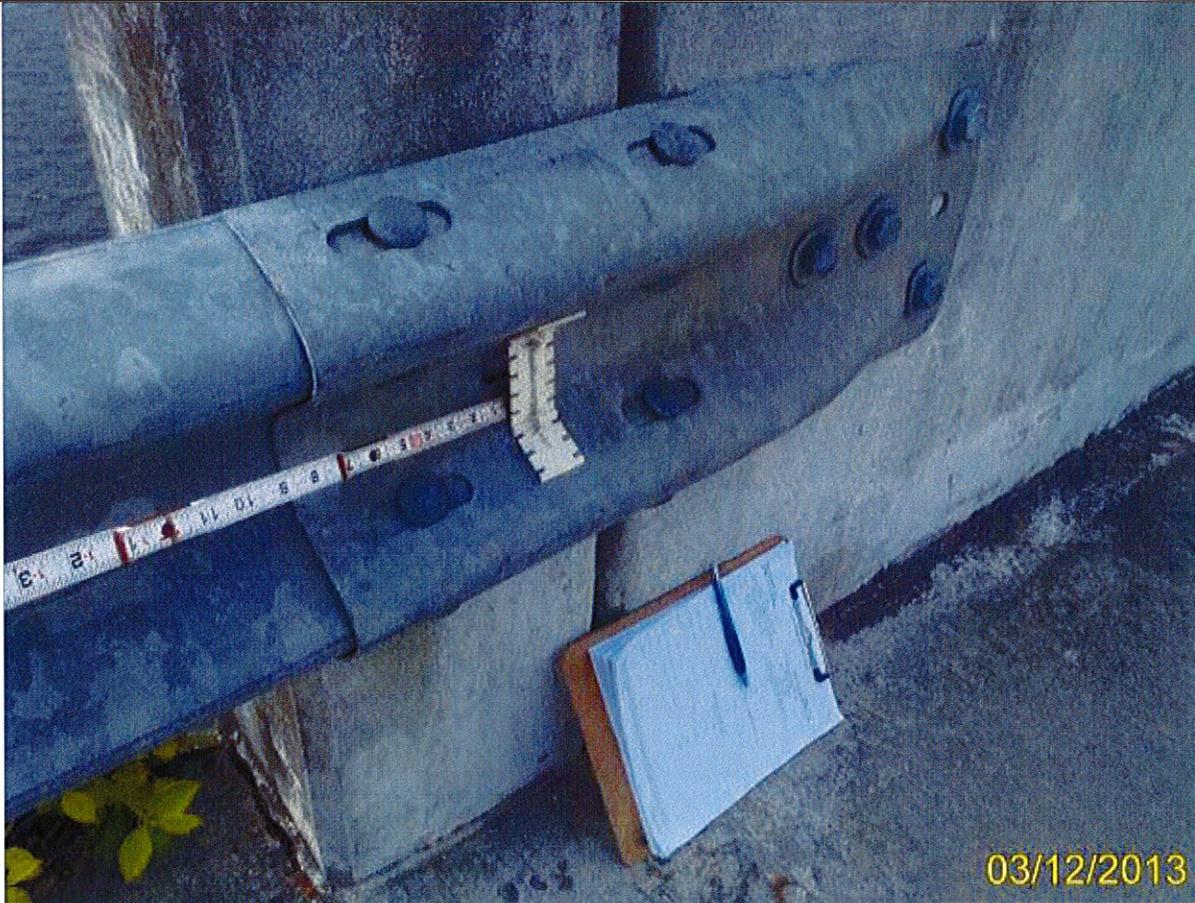
Photo 12 - Element 333 Other Bridge Railing

Most of the approach guardrail reflectors are broken – NO CHANGE. Refer to photo 12.

Typical broken guardrail reflector (southeast guardrail at Abutment 6 shown)

REPAIR RECOMMENDATION:
Replace all broken guardrail reflectors. 6MH

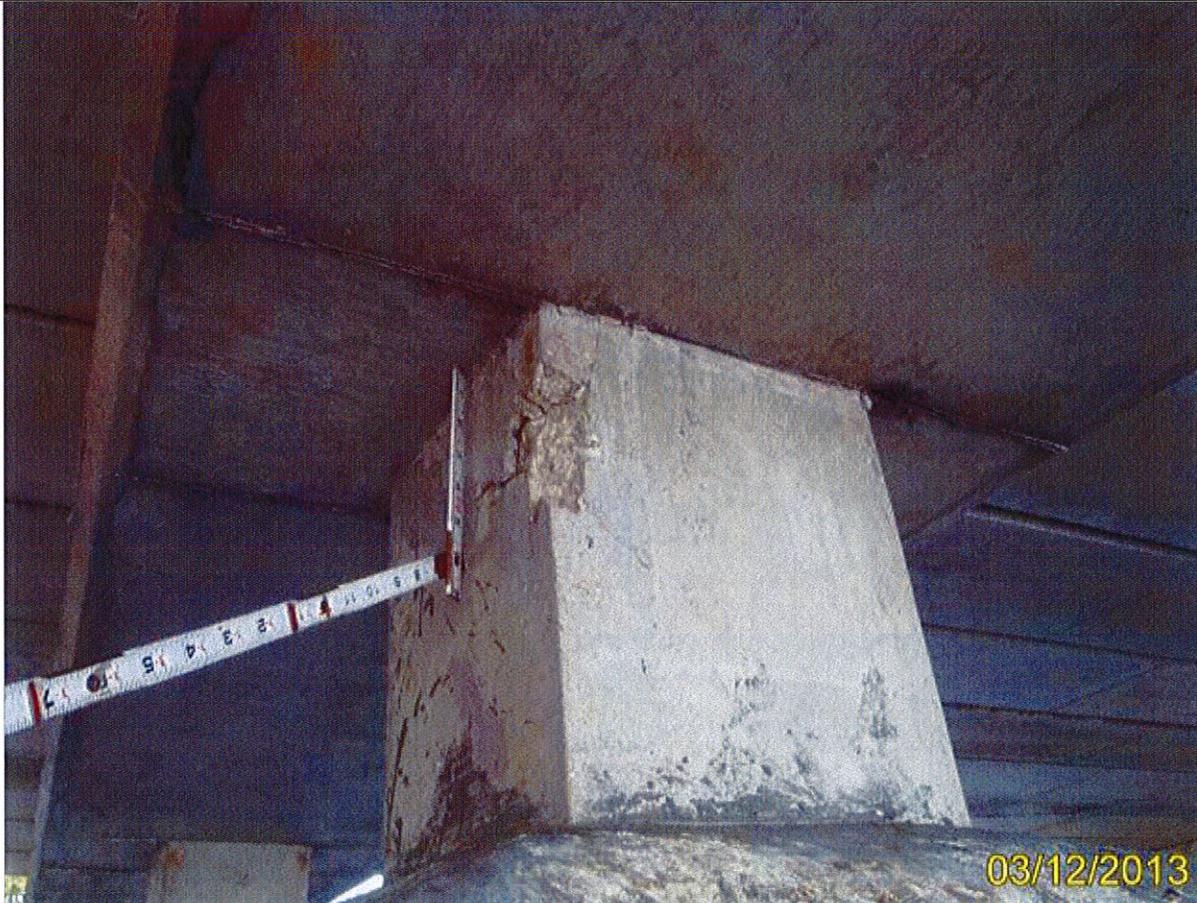
Photo 13 - Element 205 R/Conc Column

CS3:
Pile 2-5, southwest corner at cap, spall/delamination 5in. x 5in. x 1in. – NO CHANGE. Refer to photo 13.

Spall/delamination in southwest corner of Pile 2-5

REPAIR RECOMMENDATION:
None

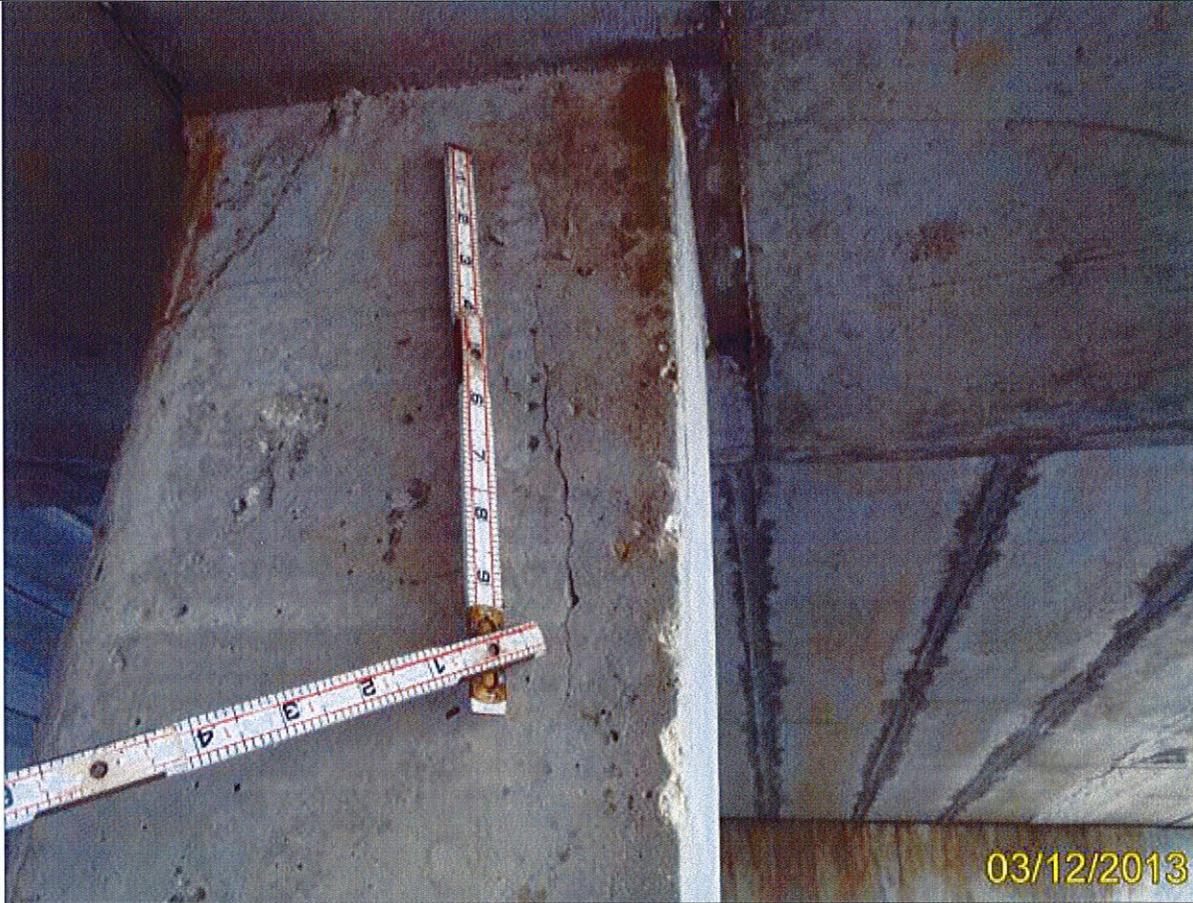
Photo 14 - Element 205 R/Conc Column

Delaminations at northwest and southwest corners of Pile 2-6 (view looking east)

REPAIR RECOMMENDATION:
None

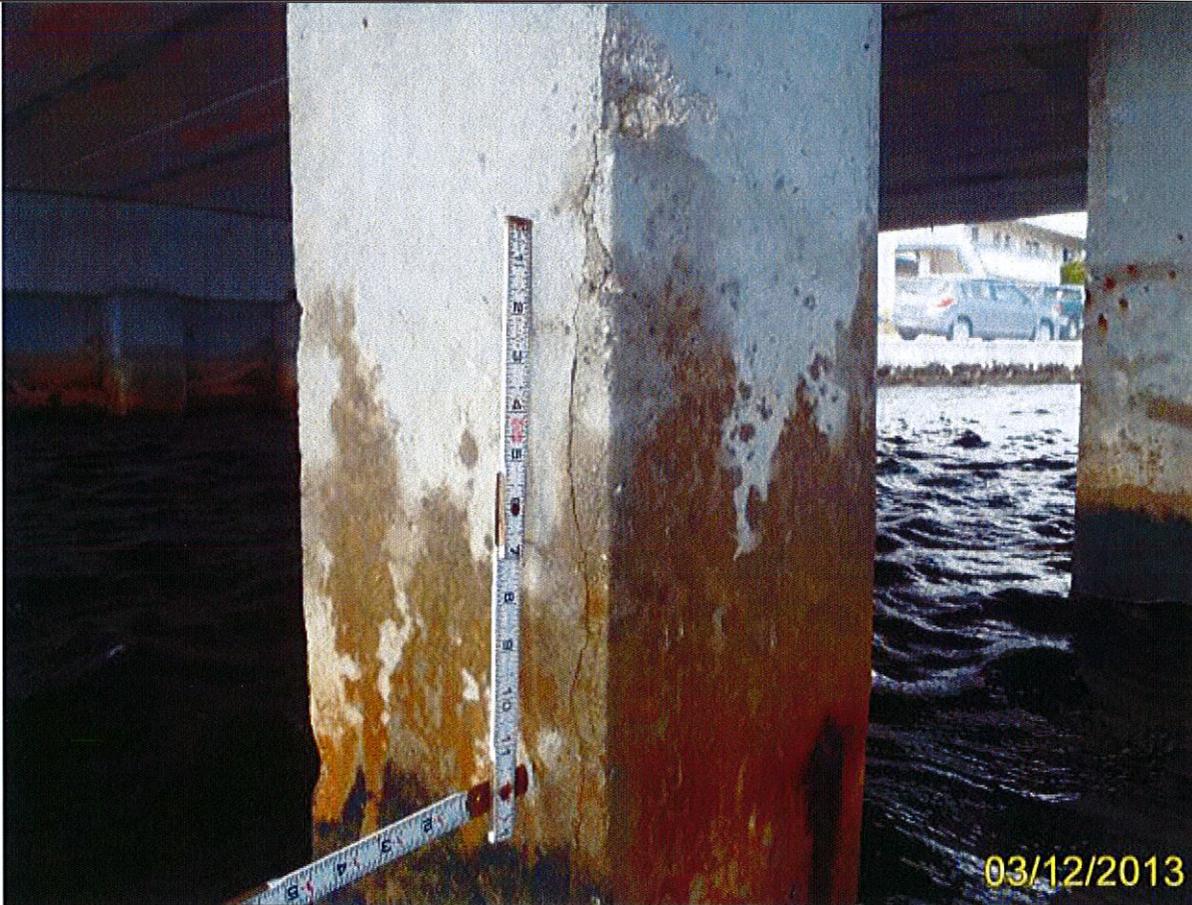
Photo 15 - Element 205 R/Conc Column

Delamination in southeast corner of Pile 2-7

REPAIR RECOMMENDATION:
None

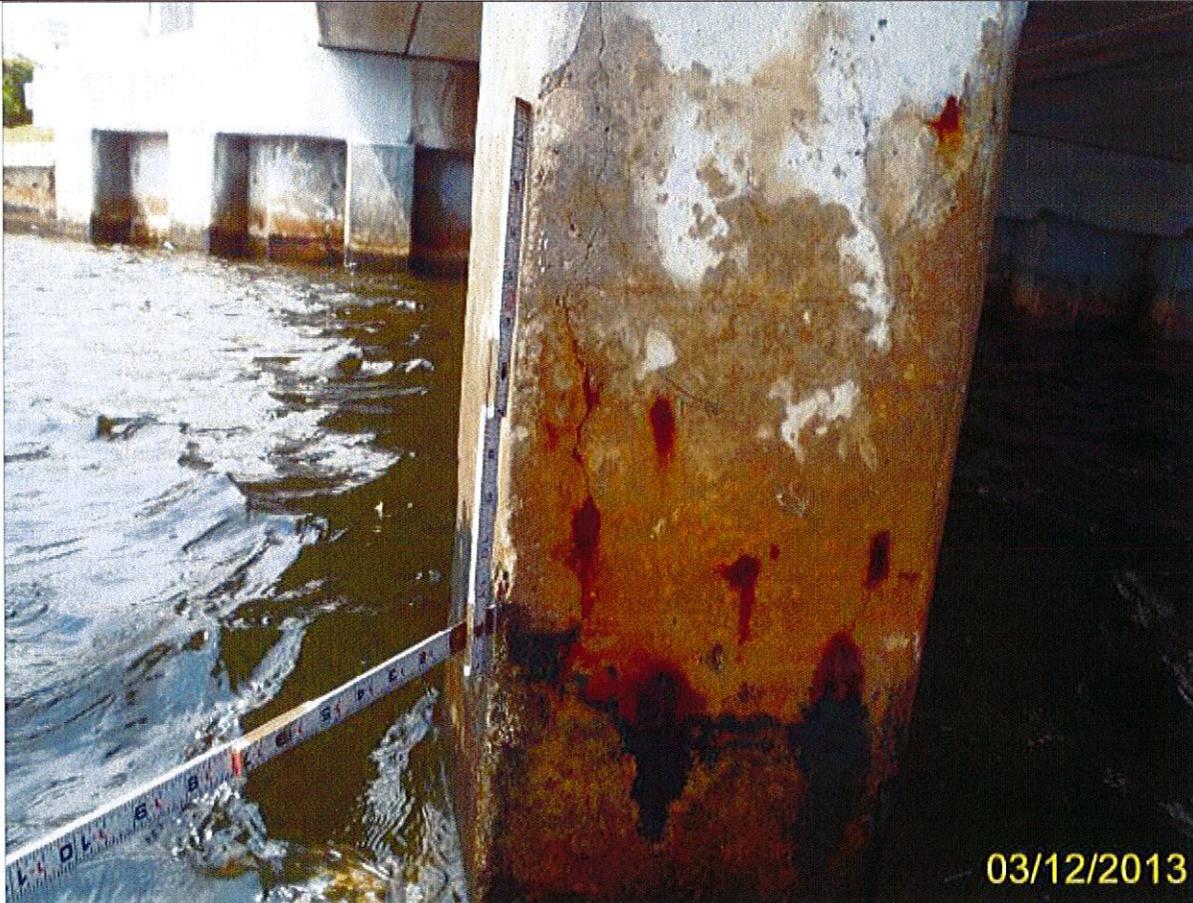
Photo 16 - Element 205 R/Conc Column

Pile 2-8, southeast and northeast corners, 3ft. below the cap, has delaminations with corrosion staining, 2ft. x 10in. - NO CHANGE. Refer to photo 16.

Delaminations with corrosion stains in east face of Pile 2-8

REPAIR RECOMMENDATION:
None

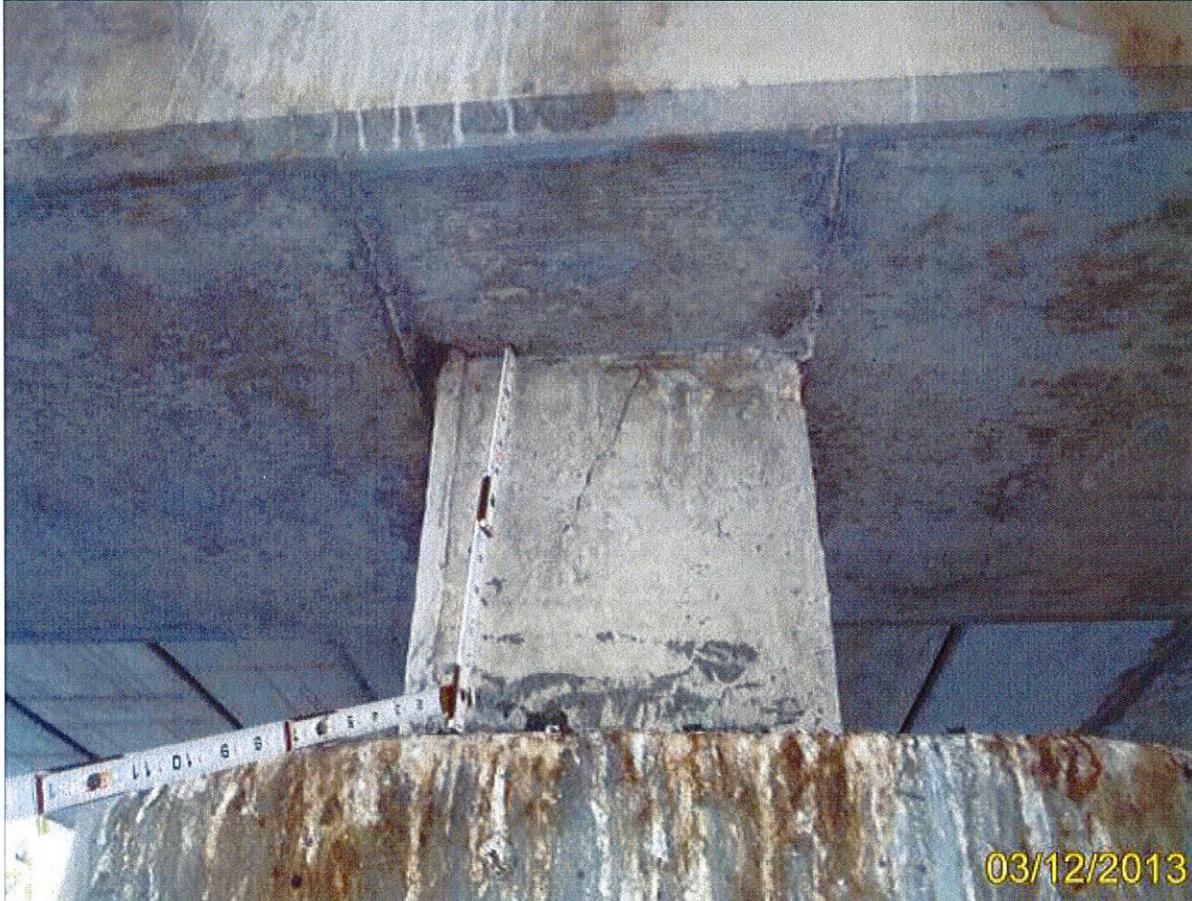
Photo 17 - Element 205 R/Conc Column

Delamination in northwest corner of Pile 3-3

REPAIR RECOMMENDATION:
None

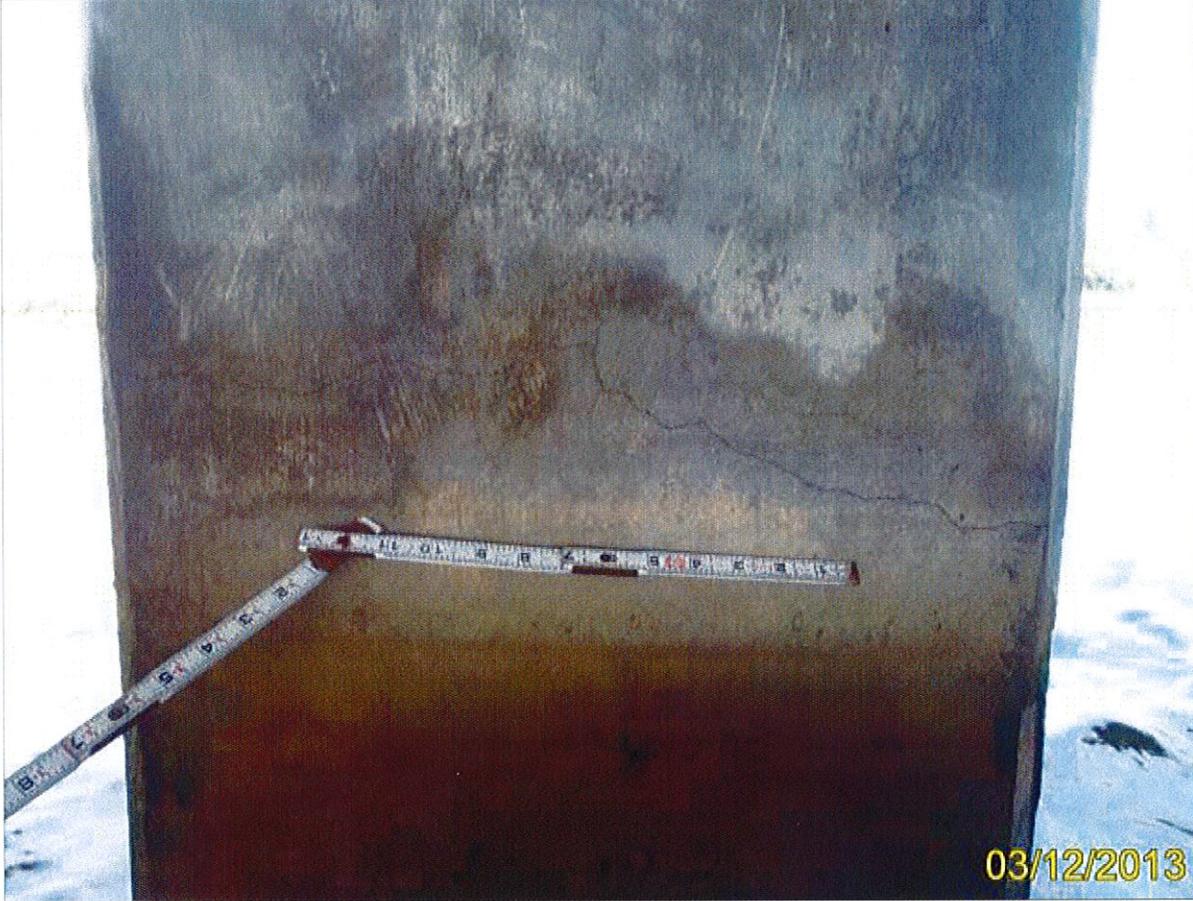
Photo 18 - Element 298 Pile Jacket Bare

The pile jackets typically exhibit vertical and horizontal cracking up to 1/64in. wide - NO CHANGE. Refer to photo 18.

Typical cracks in pile jackets (Jacket 2-2 shown)

REPAIR RECOMMENDATION:
None

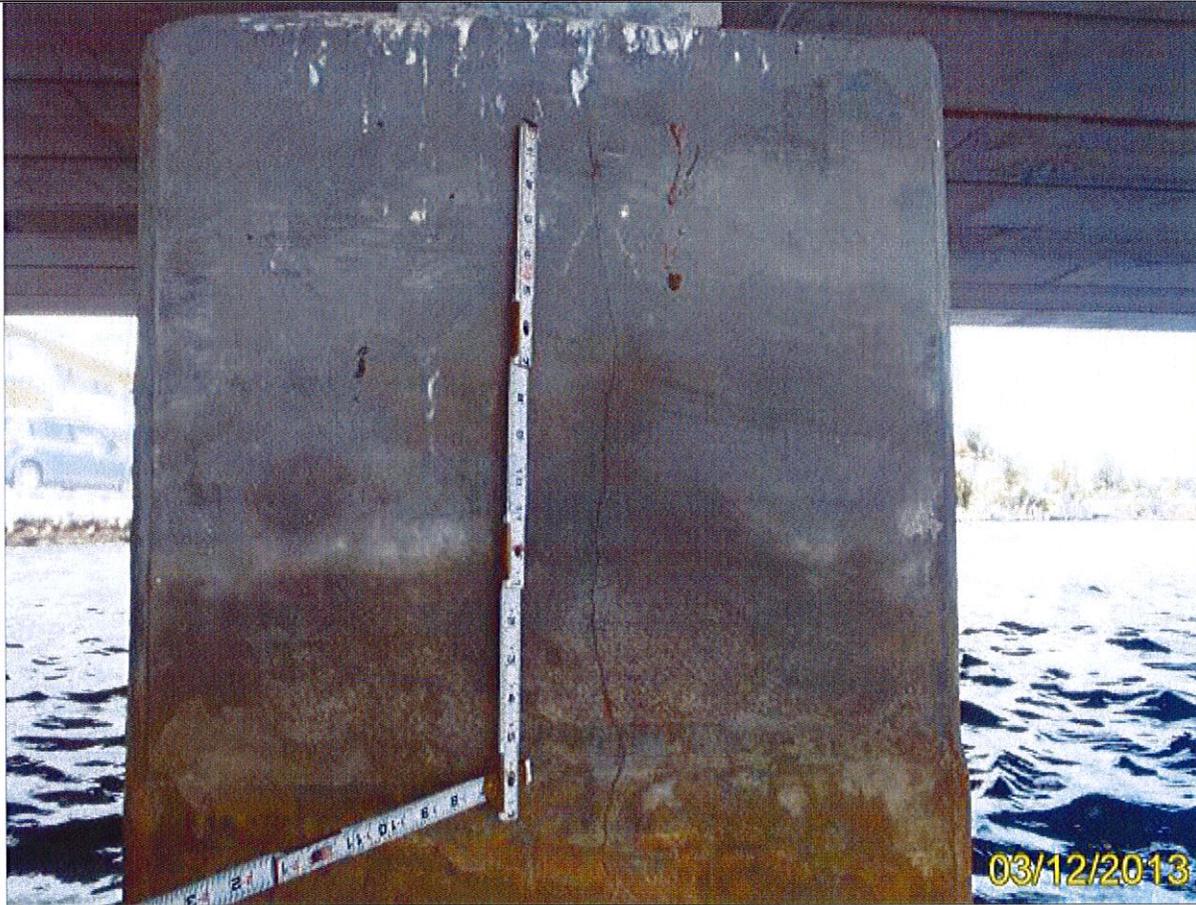
Photo 19 - Element 298 Pile Jacket Bare

The south face of Pile Jacket 2-5 has a 3ft. long x 1/16in. wide vertical crack, starting at the top - NO CHANGE. Refer to photo 19.

Vertical crack in south face of Pile Jacket 2-5

CS-2 1 Do Nothing
Jacket 2-5: South face starting at the top of the jacket, vertical crack with no corrosion bleedout, 3ft. L x 1/16in. W – NO CHANGE.

REPAIR RECOMMENDATION:
None

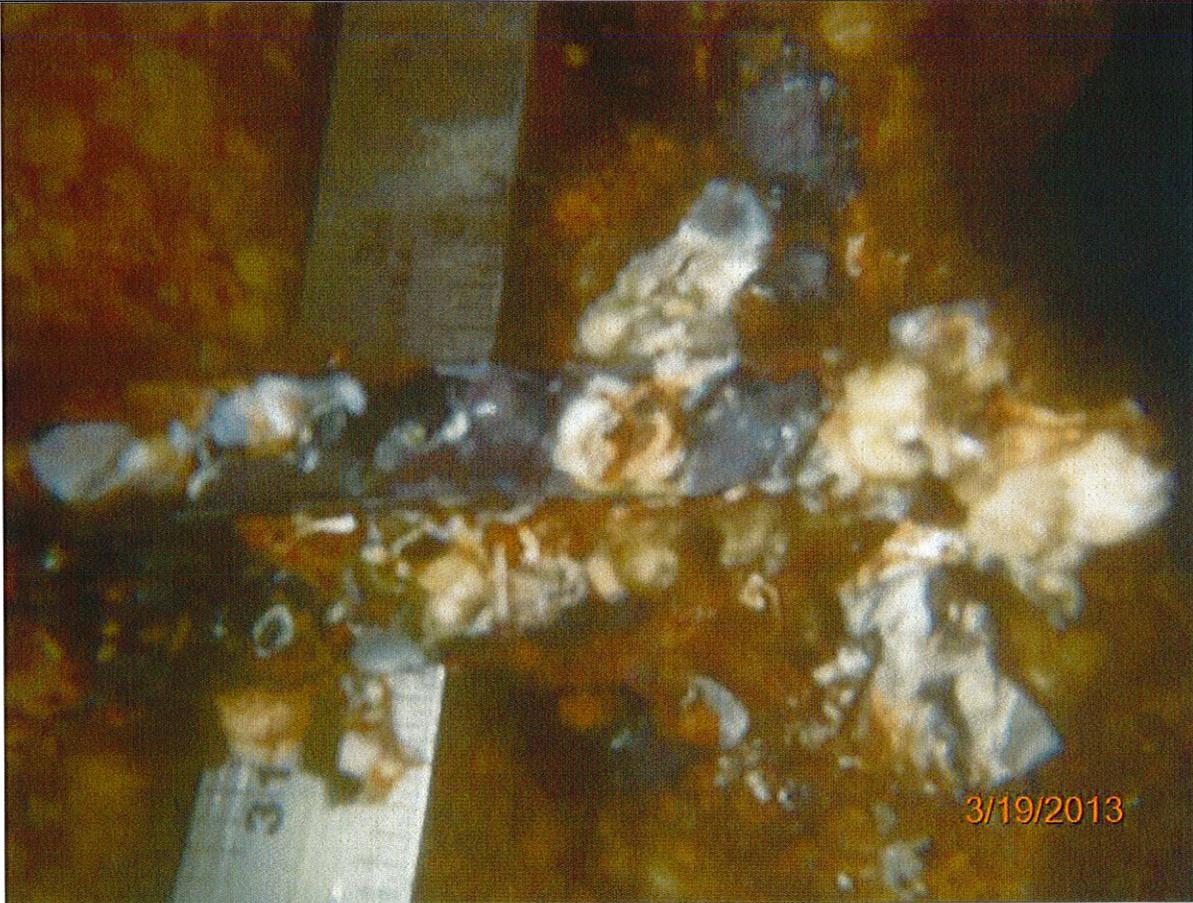
Photo 20 - Element 298 Pile Jacket Bare

Void with exposed rebar in the southwest corner of Pile Jacket 3-3

CS-3 1 REPAIR
Jacket 3-3: Southwest corner at the bottom of the jacket, void with exposed horizontal and vertical rebar, 12in. H x 24in. W x 5in. D – NEW.

REPAIR RECOMMENDATION:
None
