**FLORIDA DEPARTMENT OF TRANSPORTATION
BRIDGE MANAGEMENT SYSTEM
Inspection/CID/Bridge Profile Report**

BRIDGE ID: 868108
DISTRICT: 04 Fort Lauderdale

PAGE: 1 OF 63
INSPECTION DATE: 3/12/2013 TRQS

STRUCTURE NAME: Not Recorded
YEAR BUILT: 1959
SECTION NO.: 86 000 181
MP: 0.142
ROUTE: 00000
FACILITY CARRIED: MCNAB RD(SE 15 ST)
FEATURE INTERSECTED: CYPRESS CK C-14 CANAL

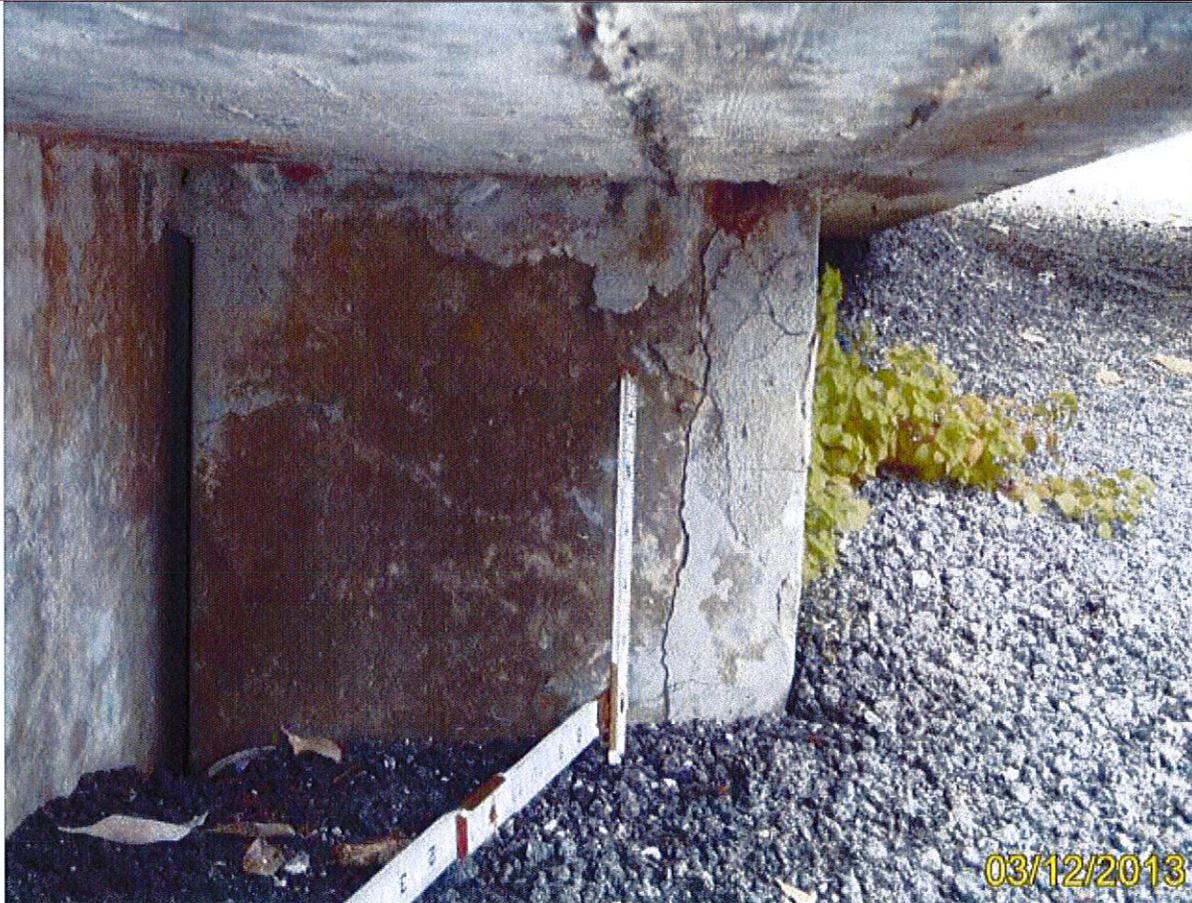
Photo 21 - Element 475 R/Conc Walls

Delaminated patch at southeast corner of second pile from west end of northwest retaining wall

Repair all spalls/delaminations in the piles and retaining walls/backwalls and clean and seal all horizontal, diagonal and vertical cracks at both abutment backwalls. 140MH

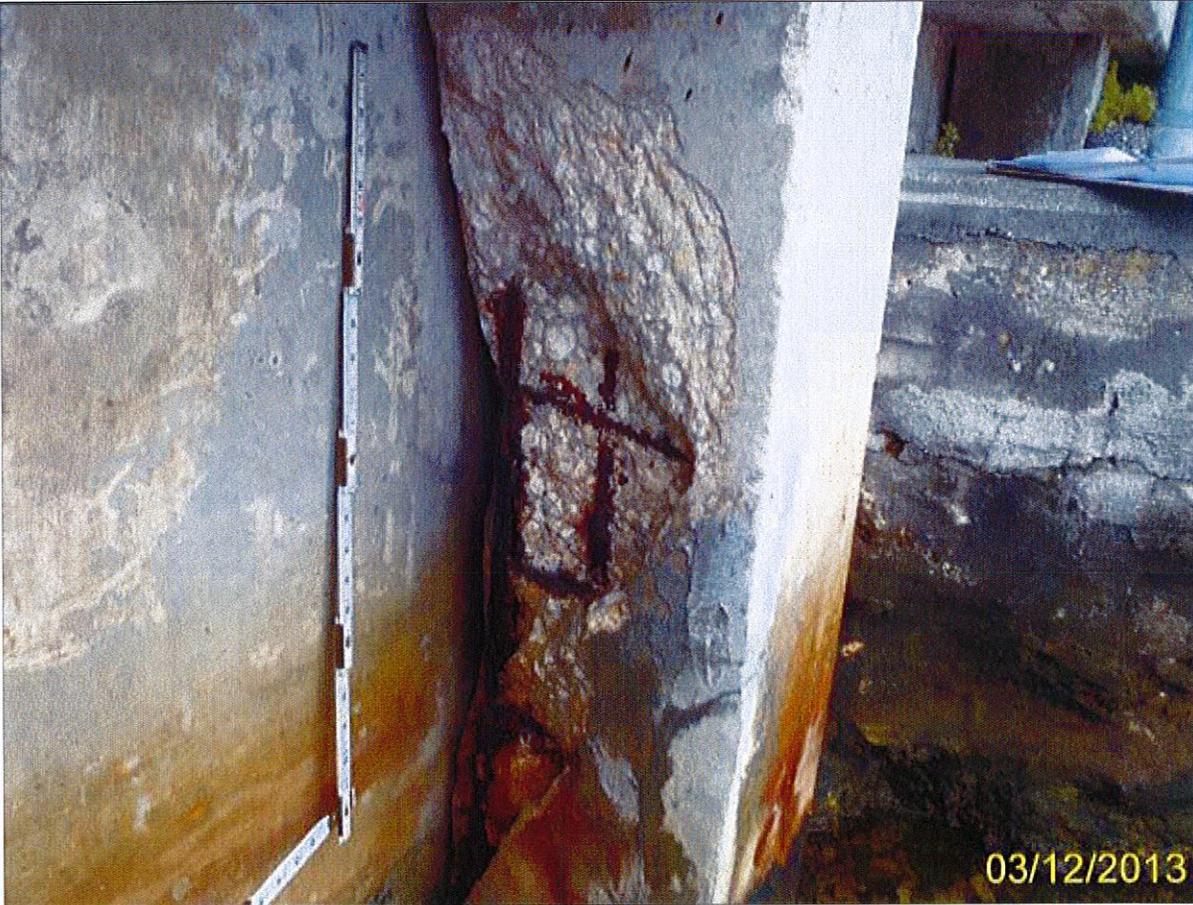
Photo 22 - Element 475 R/Conc Walls

First soldier pile from Abutment 1 of northwest retaining wall has spalls/delaminations up to 5ft. x 14in. x 2-1/2in. with exposed vertical rebar (70% section remaining), in south face and southeast corner, and a delamination 16in. x 4in. in northeast corner with corrosion staining - NO CHANGE. Refer to photo 22.

Spall/delamination with exposed vertical rebar in first soldier pile from Abutment 1 of northwest retaining wall

Repair all spalls/delaminations in the piles and retaining walls/backwalls and clean and seal all horizontal, diagonal and vertical cracks at both abutment backwalls. 140MH

REPAIR RECOMMENDATION:
Refer to photo 21.

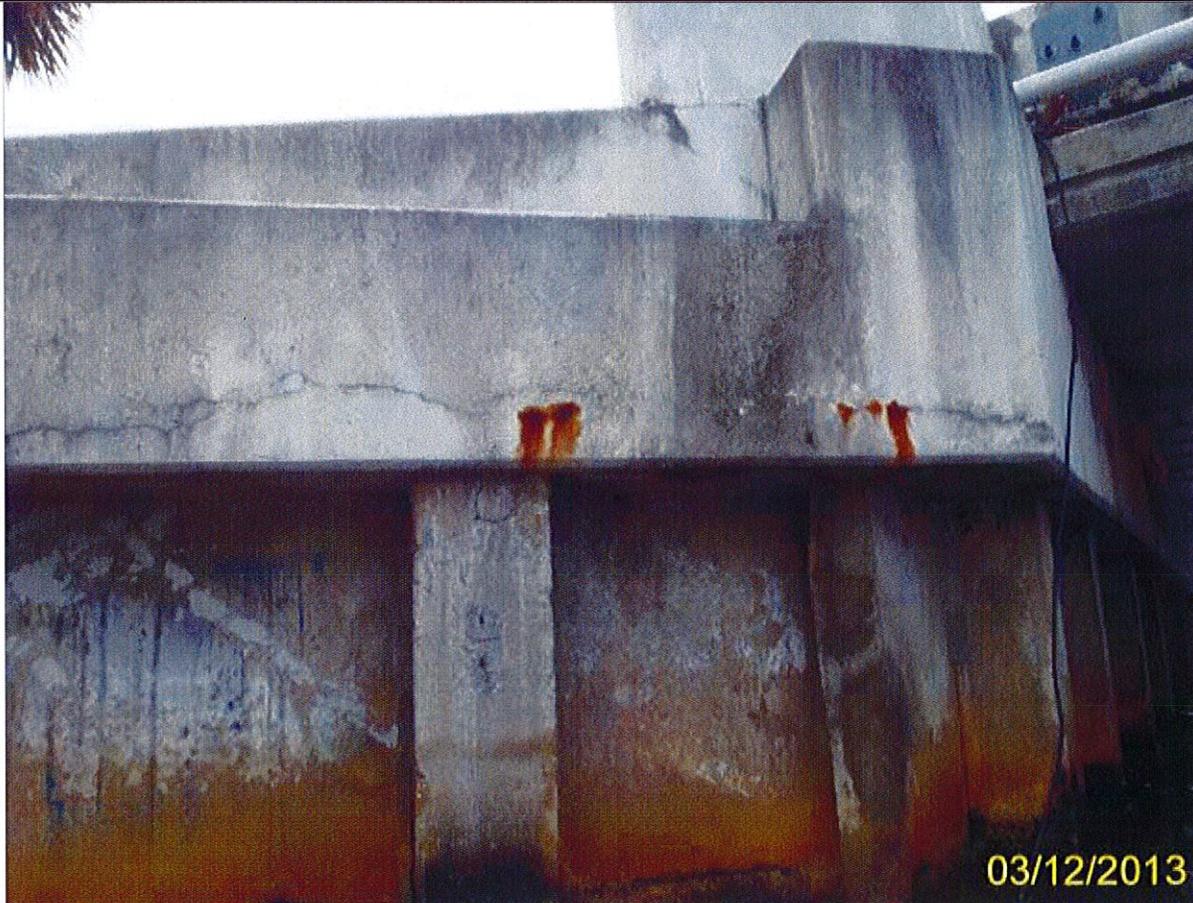
Photo 23 - Element 475 R/Conc Walls

Northeast retaining wall cap, east bottom edge, horizontal crack 12ft. long x 1/64in. wide with two areas of corrosion stains - NO CHANGE. Refer to photo 23.

Horizontal crack with corrosion stains in the east bottom edge of northeast retaining wall cap

REPAIR RECOMMENDATION:
Refer to photo 21.

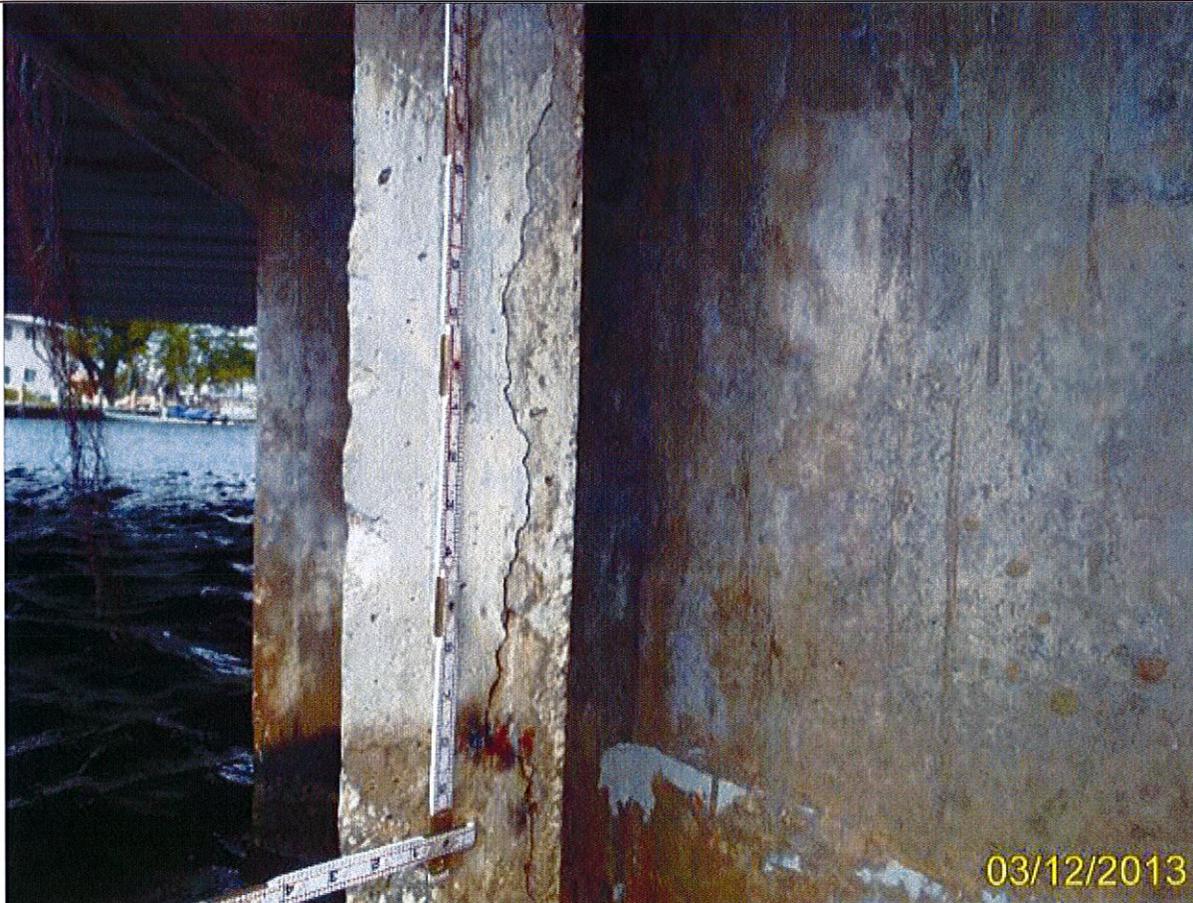
Photo 24 - Element 475 R/Conc Walls

The south and north faces of the Abutment 6 backwall each have a 6ft. high vertical crack with an associated delamination 4ft. x 9in. with corrosion stains - NO CHANGE. Refer to photo 24.

Delamination in south face of Abutment 6 backwall

REPAIR RECOMMENDATION:
Refer to photo 21.

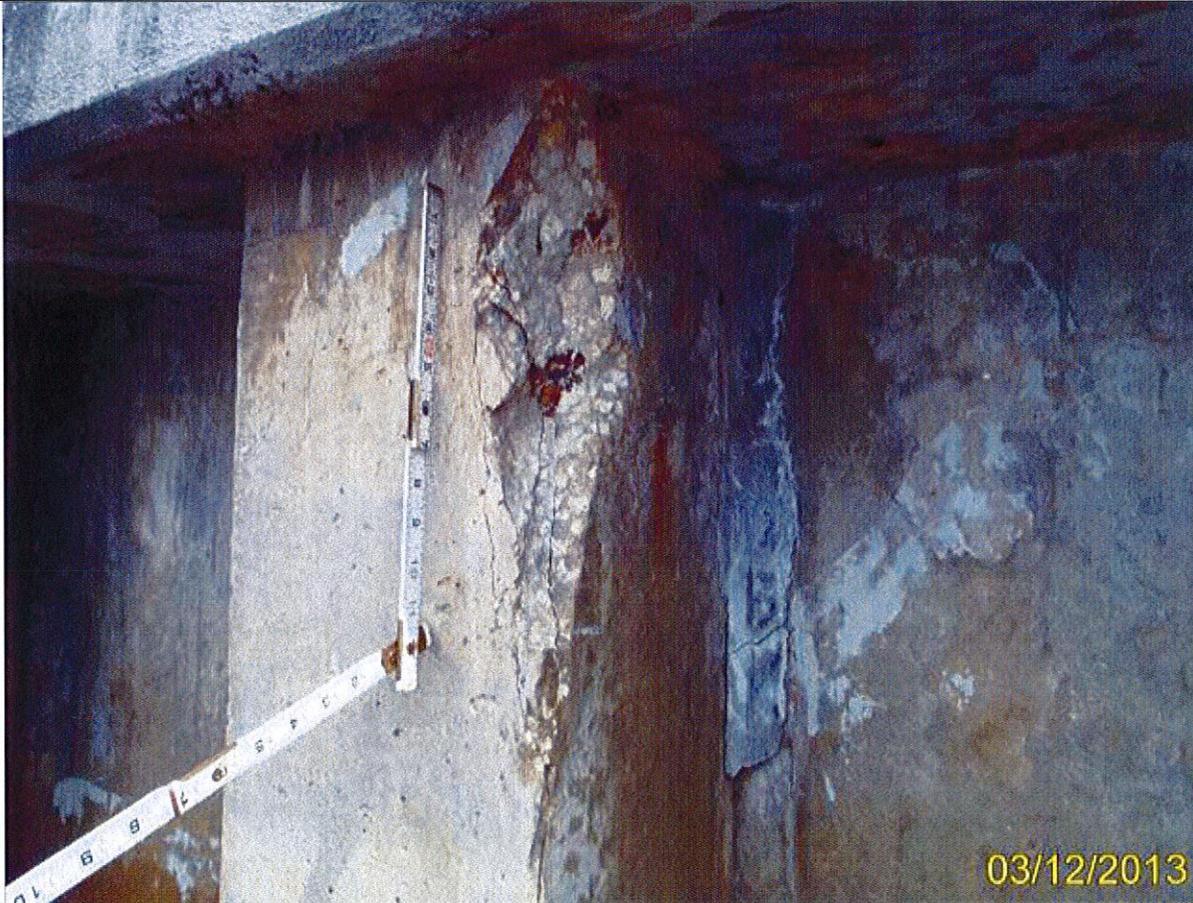
Photo 25 - Element 475 R/Conc Walls

First soldier pile east of Abutment 6 of the southeast retaining wall has a spall/delamination with exposed vertical rebar 1ft. x 3in. x 1-1/2in., on southwest corner, at cap - NO CHANGE. Refer to photo 25.

Spall/delamination with exposed rebar in southwest corner of first soldier pile from Abutment 6 of the southeast retaining wall

REPAIR RECOMMENDATION:
Refer to photo 21.

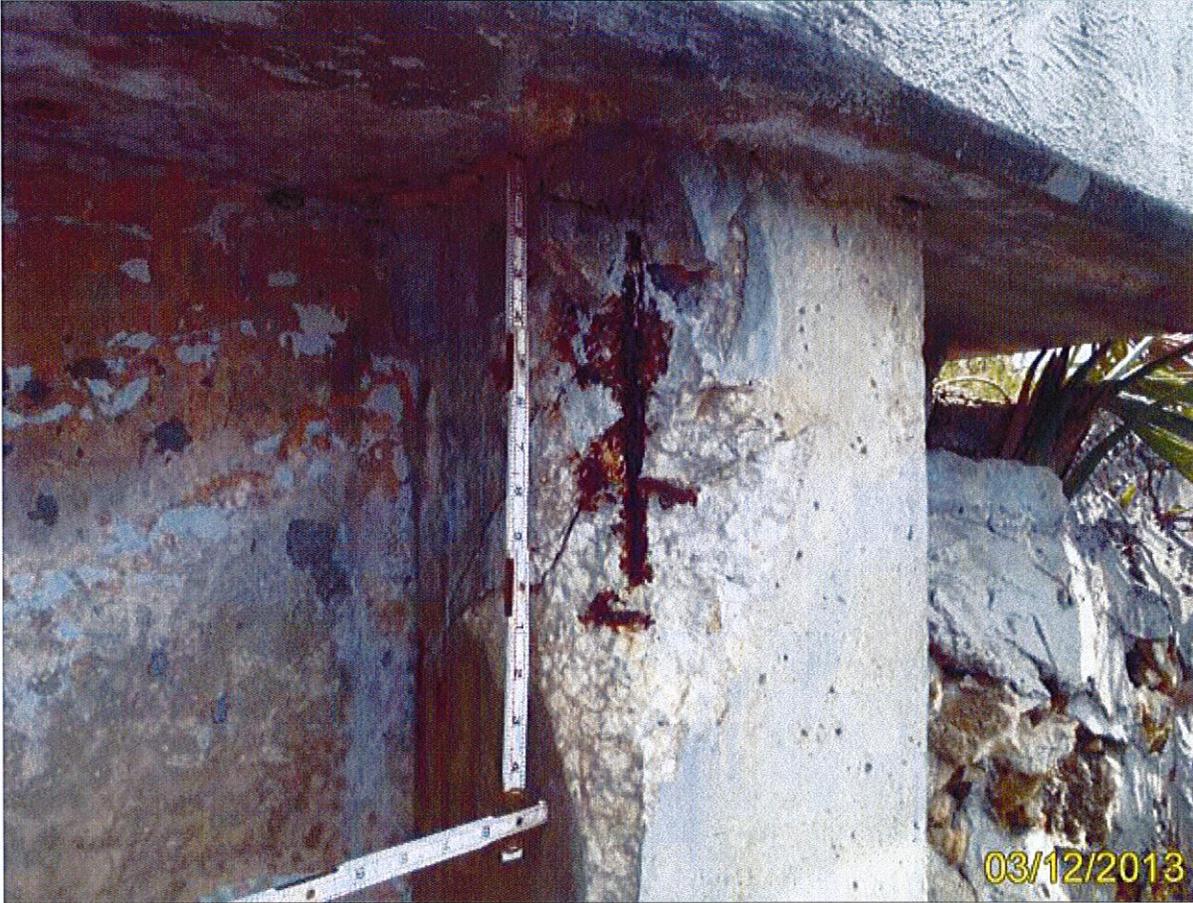
Photo 26 - Element 475 R/Conc Walls

Second soldier pile east of Abutment 6 of the southeast retaining wall has a spall/delamination, 2ft. x 10in. x 1in. with exposed vertical rebar (60% section remaining) on northwest corner, at cap - NO CHANGE. Refer to photo 26.

Spall/delamination with exposed rebar in northwest corner of second soldier pile from Abutment 6 of the southeast retaining wall

REPAIR RECOMMENDATION:
Refer to photo 21.
